# Access Compliance Report

## Public Rights-of-Way

### (Curb Ramps)

Intersection ID: 21378	Main Street: CAMBRIDGE BELTWAY DR	Cross Street: LENOX POINTE DR	Location: S
ADA ID: 6718456829CB	Ramp Type: PerpDiag	Initial Pass/Fail: Fail	Overall Compliance: No
Codes/Mitigation Info/Possible Solution		Field Measurements/Component Compliance	
Severity Score: 13.75

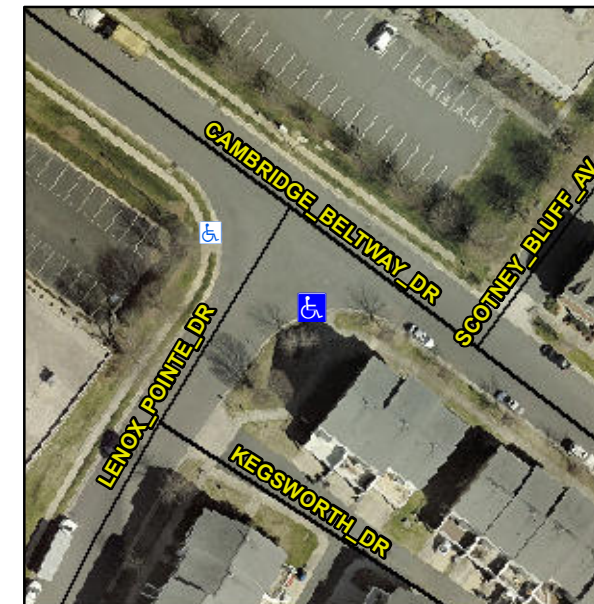
Compliance	Description	Data	Compliance	Description	Data
N/A	Ramp Length (in)	98.0	No	Ramp Slope (%)	8.9
Yes	Ramp Width (in)	51.0	No	Ramp XSlope (%)	4.1
N/A	Flare Type LT	N/A	N/A	Flare Type RT	N/A
N/A	Flare Slope LT (%)	N/A	N/A	Flare Slope RT (%)	N/A
N/A	Flare Traversable LT?	N/A	N/A	Flare Traversable RT?	N/A
N/A	Landing Length (in)	N/A	N/A	DWS Provided?	N/A
N/A	Landing Width (in)	N/A	N/A	DWS Contrast?	N/A
N/A	Landing Slope (%)	N/A	N/A	DWS Length (in)	N/A
N/A	Landing X Slope (%)	N/A	N/A	DWS Full Width?	N/A
N/A	Landing Curb? (Y/N)	N/A	N/A	DWS Offset (in)	N/A
N/A	Shared Landing?	N/A			
N/A	Gutter Ponding?	N/A	N/A	Gutter Slope (%)	N/A
N/A	Gutter Lip Ht (in)	N/A	N/A	Gutter X Slope (%)	N/A
N/A	Painted X Walk1?	No	N/A	Painted X Walk2?	No
	X Walk 1 Direction	To NE		X Walk 2 Direction	To NW
N/A	X Walk 1 Width (in)	N/A	N/A	X Walk 2 Width (in)	N/A
	X Walk 1 Slope (%)	1.0		X Walk 2 Slope (%)	0.8
	X Walk 1 X Slope (%)	1.6		X Walk 2 X Slope (%)	0.7

N/A	Ramp inside XWalk1?	N/A	N/A	Ramp inside XWalk2?	N/A
	Road Slope (%)	2.1	N/A	Clear Space?	N/A
	Road X Slope (%)	0.5	N/A	Clear Space to XWalk (in)	N/A
N/A	Any Obstructions?	N/A	N/A	Storm Grate/Utility Hazard?	N/A
	Obstruction Type			Storm Grate/Utility Type	
		N/A			N/A
			Yes	Surface Condition? (G/P)	Good

**Remove & Replace Curb Ramp With Two New Directional Ramps or Equivalent.**

**R304.2.2, R304.5.3**
