Access Compliance Report

Public Rights-of-Way

(Curb Ramps)

Intersection ID: 19259	Main Street: PEBBLESTONE_DR	Cross Street: VILLAGE_LAKE_DR	Location: NE
ADA ID: 67298D6ED443	Ramp Type: PerpDiag	Initial Pass/Fail: Fail	Overall Compliance: No
			Severity Score: 13.75

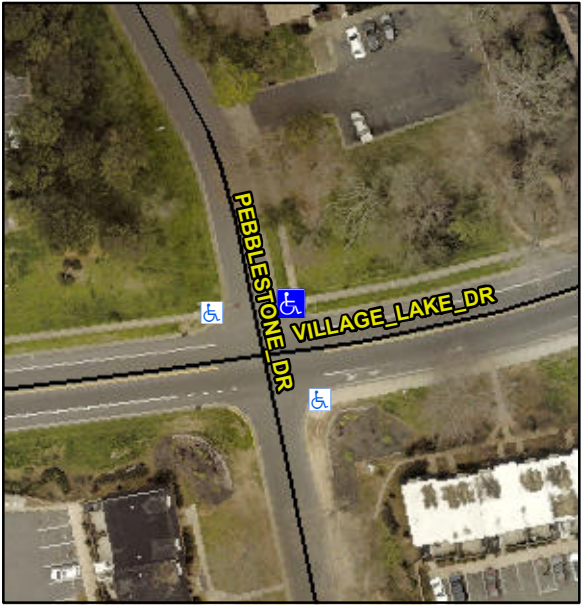
Compliance	Description	Data	Compliance	Description	Data
N/A	Ramp Length (in)	88.0	No	Ramp Slope (%)	8.6
Yes	Ramp Width (in)	48.0	No	Ramp XSlope (%)	3.9
N/A	Flare Type LT	N/A	N/A	Flare Type RT	N/A
N/A	Flare Slope LT (%)	N/A	N/A	Flare Slope RT (%)	N/A
N/A	Flare Traversable LT?	N/A	N/A	Flare Traversable RT?	N/A
N/A	Landing Length (in)	N/A	N/A	DWS Provided?	N/A
N/A	Landing Width (in)	N/A	N/A	DWS Contrast?	N/A
N/A	Landing Slope (%)	N/A	N/A	DWS Length (in)	N/A
N/A	Landing X Slope (%)	N/A	N/A	DWS Full Width?	N/A
N/A	Landing Curb? (Y/N)	N/A	N/A	DWS Offset (in)	N/A
N/A	Shared Landing?	N/A			
N/A	Gutter Ponding?	N/A	N/A	Gutter Slope (%)	N/A
N/A	Gutter Lip Ht (in)	N/A	N/A	Gutter X Slope (%)	N/A
N/A	Painted X Walk1?	No	N/A	Painted X Walk2?	No
	X Walk 1 Direction	To W		X Walk 2 Direction	To S
N/A	X Walk 1 Width (in)	N/A	N/A	X Walk 2 Width (in)	N/A
	X Walk 1 Slope (%)	5.2		X Walk 2 Slope (%)	1.9
	X Walk 1 X Slope (%)	0.1		X Walk 2 X Slope (%)	5.5

N/A	Ramp inside XWalk1?	N/A	N/A	Ramp inside XWalk2?	N/A
	Road Slope (%)	4.2	N/A	Clear Space?	N/A
	Road X Slope (%)	7.5	N/A	Clear Space to XWalk (in)	N/A
N/A	Any Obstructions?	N/A	N/A	Storm Grate/Utility Hazard?	N/A
	Obstruction Type			Storm Grate/Utility Type	
		N/A			N/A
			Yes	Surface Condition? (G/P)	Good

Possible Solutions:				
	Remove & Replace Curb Ramp With Two New Directional Ramps or Equivalent.				
	Surveyor Notes:				
	N/A				
	PROW/ADA:				
	Not Found, R304.2.2, R304.5.3				
Street 1 Name	PEBBLESTONE DR				
Stop Condition-Street 2	StopSign				
Street 2 Name	VILLAGE LAKE DR				
Stop Condition-Street 1	None				
Total Cost:		\$	3200.00
