# Access Compliance Report

## Public Rights-of-Way

### (Curb Ramps)

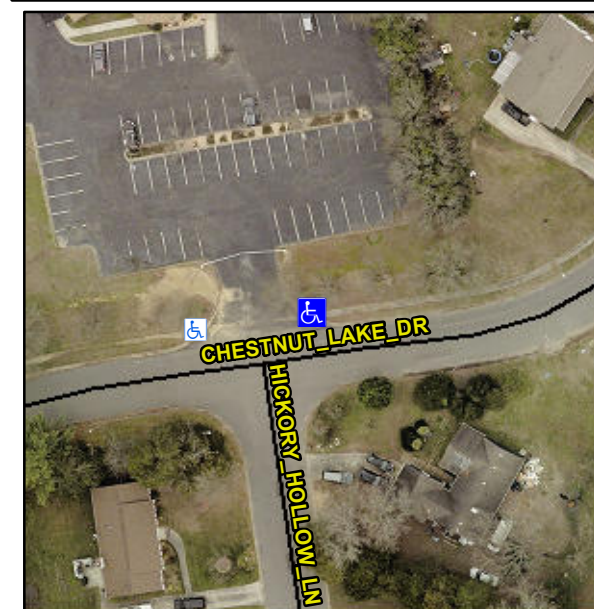
Intersection ID: 15996	Main Street: CHESTNUT_LAKE_DR	Cross Street: HICKORY_HOLLOW_LN	Location: NE
ADA ID: 6733DA4577C2	Ramp Type: Directional1	Initial Pass/Fail: Fail	Overall Compliance: No
Severity Score: 25			
Codes/Mitigation Info/Possible Solution		Field Measurements/Component Compliance

Compliance	Description	Data	Compliance	Description	Data
N/A	Ramp Length (in)	68.0	N/A	Grade Break?	N/A
Yes	Ramp Width (in)	48.0	N/A	Grade Break Slope (%)	0.0
Yes	Ramp Slope (%)	7.9	N/A	Grade Break XSlope (%)	0.0
No	Ramp XSlope (%)	8.5			
N/A	Flare Type LT	N/A	N/A	Flare Type RT	N/A
N/A	Flare Slope LT (%)	N/A	N/A	Flare Slope RT (%)	0.0
N/A	Flare Traversable LT?	N/A	N/A	Flare Traversable RT?	N/A
N/A	Landing Length (in)	0.0	N/A	DWS Provided?	N/A
N/A	Landing Width (in)	0.0	N/A	DWS Contrast?	N/A
N/A	Landing Slope (%)	0.0	N/A	DWS Length (in)	N/A
N/A	Landing X Slope (%)	0.0	N/A	DWS Full Width?	N/A
N/A	Landing Curb? (Y/N)	N/A	N/A	DWS Offset LT (in)	N/A
N/A	Shared Landing?	N/A	N/A	DWS Offset RT (in)	N/A
N/A	Gutter Ponding?	0.0	N/A	Gutter Slope (%)	N/A
N/A	Gutter Lip Ht (in)	0.0	N/A	Gutter X Slope (%)	N/A
N/A	Painted X Walk1?	No		Road Slope (%)	0.1
	X Walk 1 Direction	To W		Road X Slope (%)	1.2
	X Walk 1 Width (in)	N/A		Clear Space?	N/A

X Walk 1 Slope (%)	0.1	N/A	Clear Space to XWalk (in)	N/A
	X Walk 1 X Slope (%)	1.2	N/A	Storm Grate/Utility Hazard?	N/A
N/A	Ramp inside XWalk1?	N/A		Storm Grate/Utility Type	
N/A	Any Obstructions?	N/A			N/A
	Obstruction Type		Yes	Surface Condition? (G/P)	Good
			N/A	Curb Slope (%)	2.4

Possible Solutions:

**Remove & Replace Entire Ramp.**

**R304.5.3**

**\$ 1600.00**
