Access Compliance Report

Public Rights-of-Way

(Curb Ramps)

Intersection ID: 2499	Main Street: LAGRANDE_DR	Cross Street: HIGHLAND_CREEK_PY	Location: NE
ADA ID: 673B9D044A97	Ramp Type: PerpDiag	Initial Pass/Fail: Fail	Overall Compliance: No
Severity Score: 12.5			
Codes/Mitigation Info/Possible Solution		Field Measurements/Component Compliance

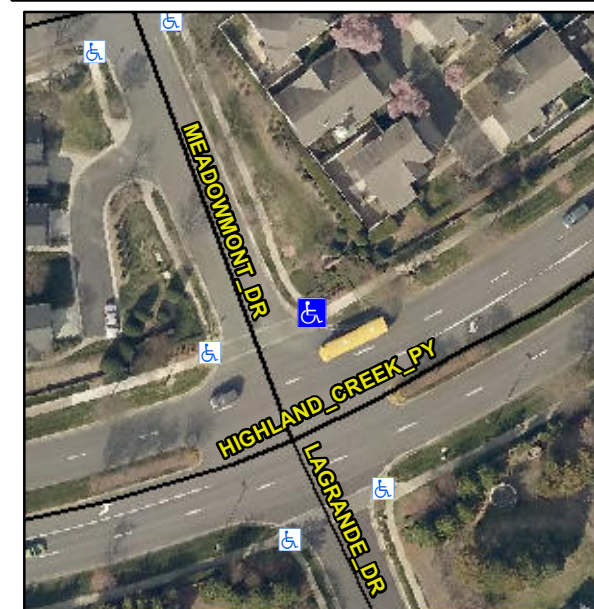
Compliance	Description	Data	Compliance	Description	Data
N/A	Ramp Length (in)	53.0	No	Ramp Slope (%)	10.1
Yes	Ramp Width (in)	53.0	Yes	Ramp XSlope (%)	1.9
N/A	Flare Type LT	N/A	N/A	Flare Type RT	N/A
N/A	Flare Slope LT (%)	N/A	N/A	Flare Slope RT (%)	N/A
N/A	Flare Traversable LT?	N/A	N/A	Flare Traversable RT?	N/A
N/A	Landing Length (in)	N/A	N/A	DWS Provided?	N/A
N/A	Landing Width (in)	N/A	N/A	DWS Contrast?	N/A
N/A	Landing Slope (%)	N/A	N/A	DWS Length (in)	N/A
N/A	Landing X Slope (%)	N/A	N/A	DWS Full Width?	N/A
N/A	Landing Curb? (Y/N)	N/A	N/A	DWS Offset (in)	N/A
N/A	Shared Landing?	N/A			
N/A	Gutter Ponding?	N/A	N/A	Gutter Slope (%)	N/A
N/A	Gutter Lip Ht (in)	N/A	N/A	Gutter X Slope (%)	N/A
N/A	Painted X Walk1?	Yes	N/A	Painted X Walk2?	No
	X Walk 1 Direction	To W		X Walk 2 Direction	To S
N/A	X Walk 1 Width (in)	81.0	N/A	X Walk 2 Width (in)	N/A
	X Walk 1 Slope (%)	1.2		X Walk 2 Slope (%)	1.8
	X Walk 1 X Slope (%)	0.7		X Walk 2 X Slope (%)	0.6

N/A	Ramp inside XWalk1?	Yes	N/A	Ramp inside XWalk2?	N/A
	Road Slope (%)	1.5	N/A	Clear Space?	N/A
	Road X Slope (%)	1.0	N/A	Clear Space to XWalk (in)	N/A
N/A	Any Obstructions?	N/A	N/A	Storm Grate/Utility Hazard?	N/A
	Obstruction Type			Storm Grate/Utility Type	
		N/A			N/A
		Yes		Surface Condition? (G/P)	Good

Possible Solutions:

Remove & Replace Curb Ramp With Two New Directional Ramps or Equivalent.

PROW/ADA:

R304.2.2
