# Access Compliance Report

## Public Rights-of-Way

### (Curb Ramps)

| Intersection ID: 43075 | Main Street: SCOTT_AV | Cross Street: ROMANY_RD | Location: SE |

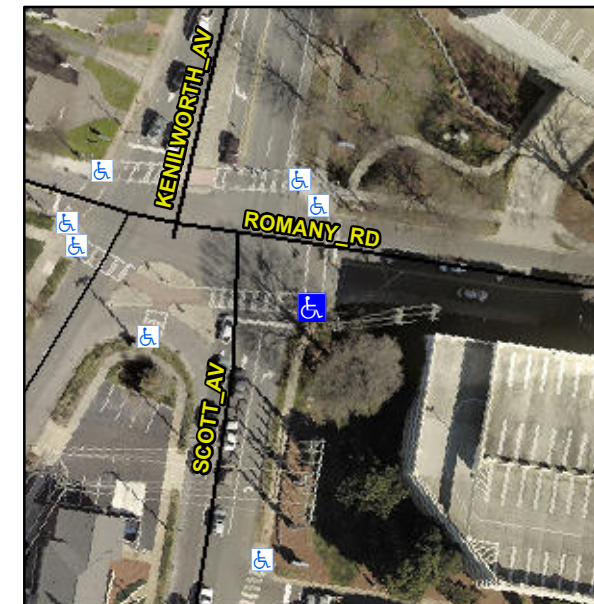
| ADA ID: 67463A03C8AD | Ramp Type: PerpDiag | Initial Pass/Fail: Fail | Overall Compliance: No |
| | | Severity Score: 37.5 | |

| Compliance | Description | Data | Compliance | Description | Data |
|---|---|---|---|---|---|
| N/A | Ramp Length (in) | 96.0 | No | Ramp Slope (%) | 11.0 |
| Yes | Ramp Width (in) | 48.0 | No | Ramp XSlope (%) | 10.3 |

**Remove & Replace Curb Ramp With Two New Directional Ramps or Equivalent.**

**R304.2.2, R304.5.3**
