Access Compliance Report

Public Rights-of-Way

(Curb Ramps)

Intersection ID: 32201	Main Street: HUXLEY_RD	Cross Street: REAVENCREST_PARK_DR	Location: SW
ADA ID: 675CBB8E81CC	Ramp Type: PerpDiag	Initial Pass/Fail: Fail	Overall Compliance: No
Severity Score: 30			
Codes/Mitigation Info/Possible Solution		Field Measurements/Component Compliance

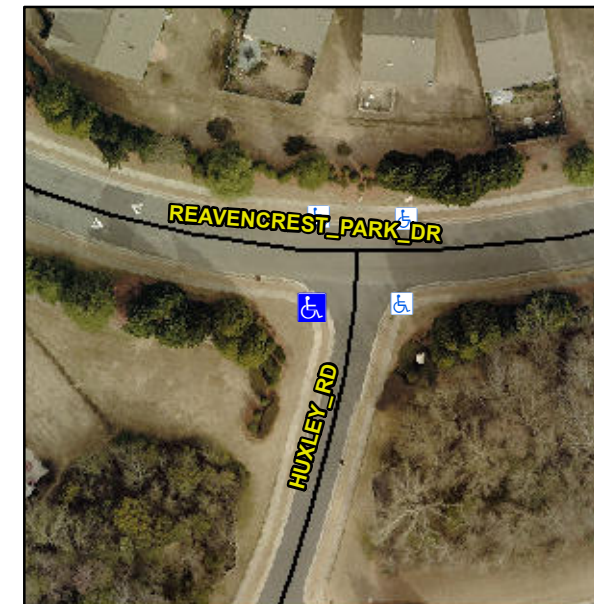
R304.5.1, R304.5.3

Compliance	Description	Data	Compliance	Description	Data
N/A	Ramp Length (in)	96.0	Yes	Ramp Slope (%)	6.3
No	Ramp Width (in)	34.0	No	Ramp XSlope (%)	6.5
N/A	Flare Type LT	N/A	N/A	Flare Type RT	N/A
N/A	Flare Slope LT (%)	N/A	N/A	Flare Slope RT (%)	N/A
N/A	Flare Traversable LT?	N/A	N/A	Flare Traversable RT?	N/A
N/A	Landing Length (in)	N/A	N/A	DWS Provided?	N/A
N/A	Landing Width (in)	N/A	N/A	DWS Contrast?	N/A
N/A	Landing Slope (%)	N/A	N/A	DWS Length (in)	N/A
N/A	Landing X Slope (%)	N/A	N/A	DWS Full Width?	N/A
N/A	Landing Curb? (Y/N)	N/A	N/A	DWS Offset (in)	N/A
N/A	Shared Landing?	N/A			
N/A	Gutter Ponding?	N/A	N/A	Gutter Slope (%)	N/A
N/A	Gutter Lip Ht (in)	N/A	N/A	Gutter X Slope (%)	N/A
N/A	Painted X Walk1?	No	N/A	Painted X Walk2?	No
	X Walk 1 Direction	To E		X Walk 2 Direction	To N
N/A	X Walk 1 Width (in)	N/A	N/A	X Walk 2 Width (in)	N/A
	X Walk 1 Slope (%)	2.1		X Walk 2 Slope (%)	3.8
	X Walk 1 X Slope (%)	5.6		X Walk 2 X Slope (%)	2.4

N/A	Ramp inside XWalk1?	N/A	N/A	Ramp inside XWalk2?	N/A
	Road Slope (%)	5.3	N/A	Clear Space?	N/A
	Road X Slope (%)	0.9	N/A	Clear Space to XWalk (in)	N/A
N/A	Any Obstructions?	N/A	N/A	Storm Grate/Utility Hazard?	N/A
	Obstruction Type			Storm Grate/Utility Type	
		N/A			N/A
		Yes		Surface Condition? (G/P)	Good

Possible Solutions:

Remove & Replace Curb Ramp With Two New Directional Ramps or Equivalent.
