Access Compliance Report

Public Rights-of-Way

(Curb Ramps)

Intersection ID: 6143	Main Street: COREOPSIS_RD	Cross Street: YARROW_RD	Location: SW
ADA ID: 676A297AFD58	Ramp Type: Perp	Initial Pass/Fail: Fail	Overall Compliance: No
Codes/Mitigation Info/Possible Solution		Field Measurements/Component Compliance	
Severity Score: 13.75

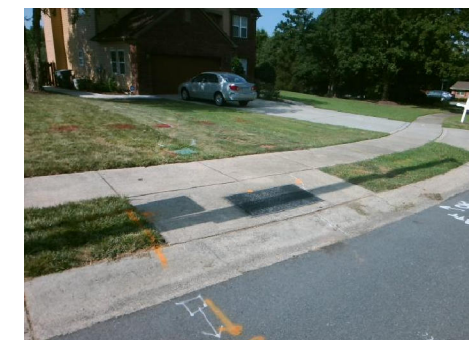
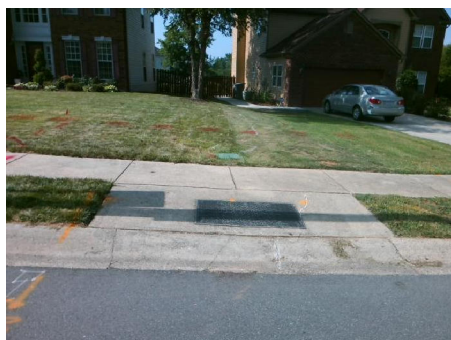
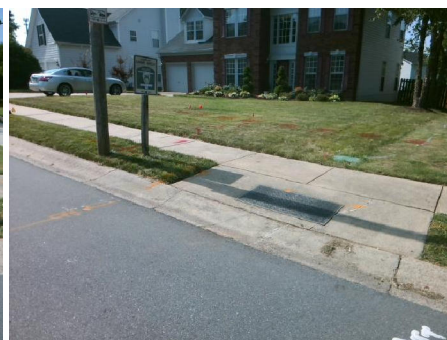
Compliance	Description	Data	Compliance	Description	Data
N/A	Ramp Length (in)	47.0	No	Ramp Slope (%)	11.1
Yes	Ramp Width (in)	66.0	Yes	Ramp XSlope (%)	3.5
N/A	Flare Type LT	N/A	N/A	Flare Type RT	N/A
N/A	Flare Slope LT (%)	N/A	N/A	Flare Slope RT (%)	N/A
N/A	Flare Traversable LT?	N/A	N/A	Flare Traversable RT?	N/A
N/A	Landing Length (in)	N/A	N/A	DWS Provided?	N/A
N/A	Landing Width (in)	N/A	N/A	DWS Contrast?	N/A
N/A	Landing Slope (%)	N/A	N/A	DWS Length (in)	N/A
N/A	Landing X Slope (%)	N/A	N/A	DWS Full Width?	N/A
N/A	Landing Curb? (Y/N)	N/A	N/A	DWS Offset (in)	N/A
N/A	Shared Landing?	N/A			
N/A	Gutter Ponding?	N/A	N/A	Gutter Slope (%)	N/A
N/A	Gutter Lip Ht (in)	N/A	N/A	Gutter X Slope (%)	N/A
N/A	Painted X Walk1?	No	N/A	Painted X Walk2?	N/A
	X Walk 1 Direction	To N		X Walk 2 Direction	N/A
N/A	X Walk 1 Width (in)	N/A	N/A	X Walk 2 Width (in)	N/A
	X Walk 1 Slope (%)	3.9		X Walk 2 Slope (%)	N/A
	X Walk 1 X Slope (%)	3.6		X Walk 2 X Slope (%)	N/A

N/A	Ramp inside XWalk1?	N/A	N/A	Ramp inside XWalk2?	N/A
	Road Slope (%)	N/A	N/A	Clear Space?	N/A
	Road X Slope (%)	N/A	N/A	Clear Space to XWalk (in)	N/A
N/A	Any Obstructions?	N/A	N/A	Storm Grate/Utility Hazard?	N/A
	Obstruction Type			Storm Grate/Utility Type	
		N/A			N/A
			Yes	Surface Condition? (G/P)	Good

Remove & Replace Entire Ramp.
