Access Compliance Report

Public Rights-of-Way

(Curb Ramps)

| Intersection ID: 3346 | Main Street: BARRISTER_WY | Cross Street: STEINBECK_CT | Location: S |

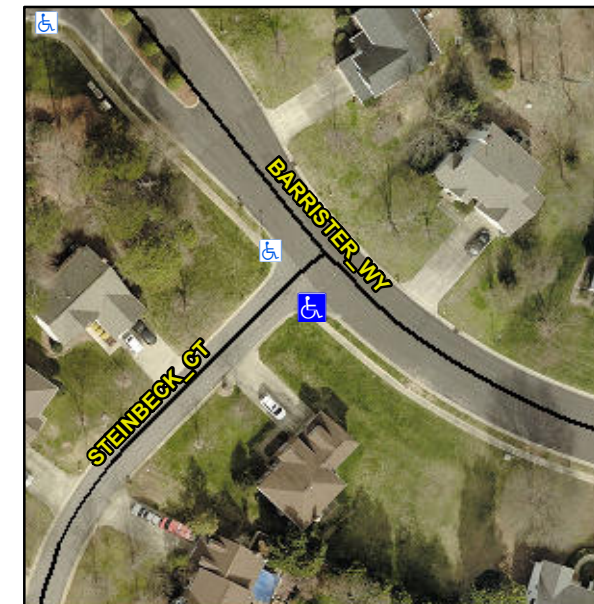
| ADA ID: 676F641952EB | Ramp Type: BlendTrans2 | Initial Pass/Fail: Fail | Overall Compliance: No |
| | | Severity Score: 8.75 | |

Not Found, R304.5.1

| Compliance | Description | Data | Compliance | Description | Data |
|---|---|---|---|---|---|
| No | Ramp Width (in) | 43.0 | Yes | BlendTrans XSlope (%) | 0.2 |
| | | | No | Curb Slope (%) | 12.8 |

Remove & Replace Curb Ramp With Two New Directional Ramps or Equivalent.
