Access Compliance Report

Public Rights-of-Way

(Curb Ramps)

Intersection ID: 1001095	Main Street: MALLARD_CREEK_RD	Cross Street: N/A	Location: NW
ADA ID: 67830D4AB03D	Ramp Type: Perp	Initial Pass/Fail: Fail	Overall Compliance: No
			Severity Score: 25

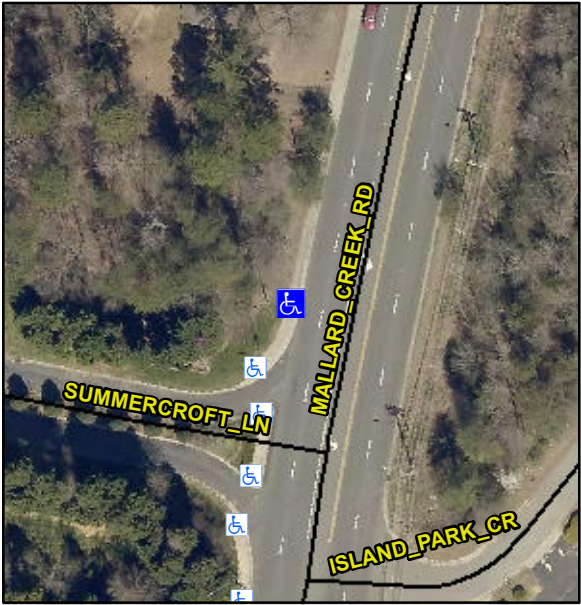
Possible Solutions:		Compliance	Description	Data
	Remove & Replace Entire Ramp.		N/A	Ramp Length (in)	60.0
			Yes	Ramp Width (in)	48.0
			N/A	Flare Type LT	N/A
			N/A	Flare Slope LT (%)	N/A
			N/A	Flare Traversable LT?	N/A
			N/A	Landing Length (in)	N/A
			N/A	Landing Width (in)	N/A
			N/A	Landing Slope (%)	N/A
			N/A	Landing X Slope (%)	N/A
<p>Surveyor Notes:</p> <p>N/A</p> <p>PROW/ADA:</p> <p>Not Found, R304.2.2, R304.5.3</p>			N/A	Flare Type RT	N/A
			N/A	Flare Slope RT (%)	N/A
			N/A	Flare Traversable RT?	N/A
			N/A	DWS Provided?	N/A
			N/A	DWS Contrast?	N/A
			N/A	DWS Length (in)	N/A
			N/A	DWS Full Width?	N/A
			N/A	DWS Offset (in)	N/A
			N/A	Shared Landing?	N/A
			N/A	Gutter Ponding?	N/A
			N/A	Gutter Lip Ht (in)	1.0
			N/A	Painted X Walk1?	No
				X Walk 1 Direction	To E
			N/A	X Walk 1 Width (in)	N/A
				X Walk 1 Slope (%)	2.1

X Walk 1 X Slope (%)	5.1
			N/A	Ramp inside XWalk1?	N/A
				Road Slope (%)	N/A
				Road X Slope (%)	N/A
			N/A	Any Obstructions?	N/A
				Obstruction Type	
Total Cost:		\$ 1850.00			
			N/A		N/A
			Yes	Surface Condition? (G/P)	Good
