# Access Compliance Report

## Public Rights-of-Way

### (Curb Ramps)

Intersection ID: 18573	Main Street: PLEASANT_DR	Cross Street: WHEELER_DR	Location: E
ADA ID: 6784A73C06CB	Ramp Type: PerpDiag	Initial Pass/Fail: Fail	Overall Compliance: No
		Severity Score: 12.5

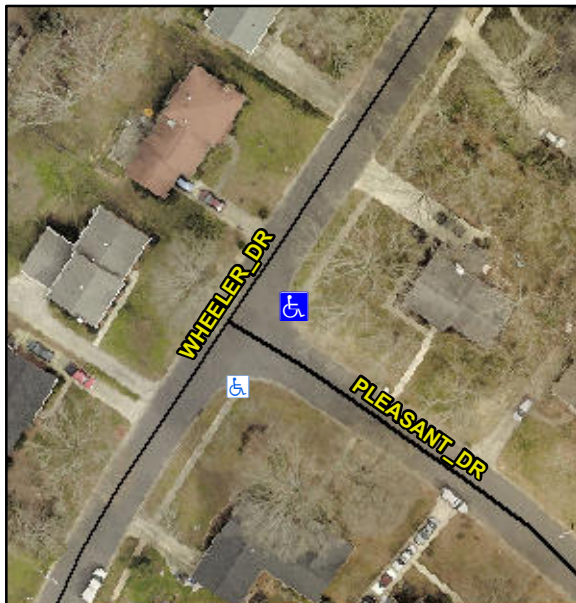
**Not Found, R304.2.2**

Compliance	Description	Data	Compliance	Description	Data
N/A	Ramp Length (in)	30.0	No	Ramp Slope (%)	9.2
Yes	Ramp Width (in)	48.0	Yes	Ramp XSlope (%)	0.0
N/A	Flare Type LT	N/A	N/A	Flare Type RT	N/A
N/A	Flare Slope LT (%)	N/A	N/A	Flare Slope RT (%)	N/A
N/A	Flare Traversable LT?	N/A	N/A	Flare Traversable RT?	N/A
N/A	Landing Length (in)	N/A	N/A	DWS Provided?	N/A
N/A	Landing Width (in)	N/A	N/A	DWS Contrast?	N/A
N/A	Landing Slope (%)	N/A	N/A	DWS Length (in)	N/A
N/A	Landing X Slope (%)	N/A	N/A	DWS Full Width?	N/A
N/A	Landing Curb? (Y/N)	N/A	N/A	DWS Offset (in)	N/A
N/A	Shared Landing?	N/A			
N/A	Gutter Ponding?	N/A	N/A	Gutter Slope (%)	N/A
N/A	Gutter Lip Ht (in)	N/A	N/A	Gutter X Slope (%)	N/A
N/A	Painted X Walk1?	No	N/A	Painted X Walk2?	No
	X Walk 1 Direction	To NW		X Walk 2 Direction	To SW
N/A	X Walk 1 Width (in)	N/A	N/A	X Walk 2 Width (in)	N/A
	X Walk 1 Slope (%)	3.0		X Walk 2 Slope (%)	1.9
	X Walk 1 X Slope (%)	3.1		X Walk 2 X Slope (%)	2.8

N/A	Ramp inside XWalk1?	N/A	N/A	Ramp inside XWalk2?	N/A
	Road Slope (%)	0.2	N/A	Clear Space?	N/A
	Road X Slope (%)	5.0	N/A	Clear Space to XWalk (in)	N/A
N/A	Any Obstructions?	N/A	N/A	Storm Grate/Utility Hazard?	N/A
	Obstruction Type			Storm Grate/Utility Type	
		N/A			N/A
			Yes	Surface Condition? (G/P)	Good

**Remove & Replace Curb Ramp With Two New Directional Ramps or Equivalent.**
