Access Compliance Report

Public Rights-of-Way

(Curb Ramps)

| Intersection ID: 18996 | Main Street: E_INDEPENDENCE_BV | Cross Street: MARGARET WALLACE RD | Location: SE |

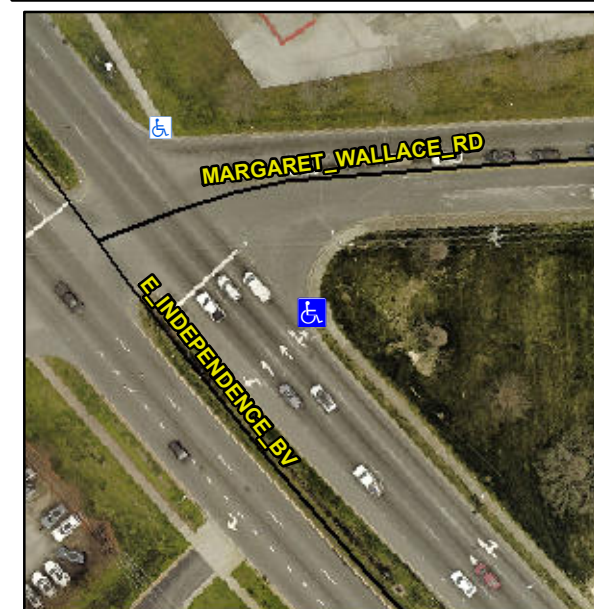
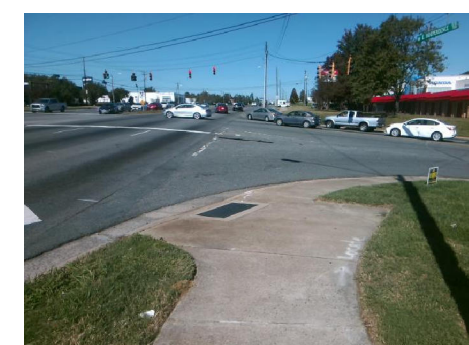
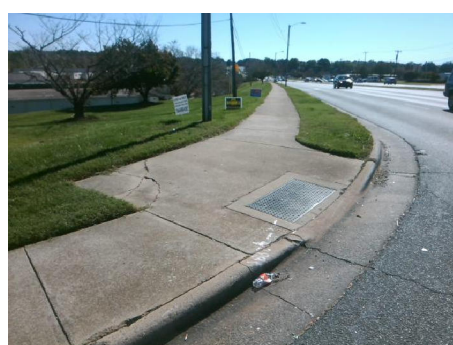
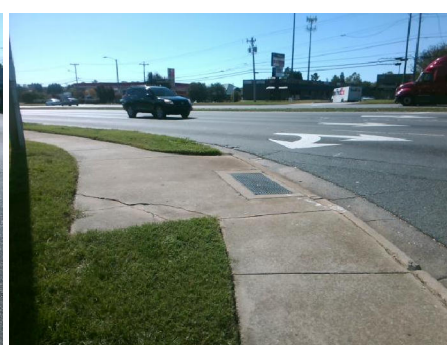
| ADA ID: 67850523527E | Ramp Type: Perp | Initial Pass/Fail: Pass | Overall Compliance: No |

Not Found, R304.2.1, R304.2.2-Perp, R304.3.2-Para, R304.5.3, R305.1.4, R305.2

| Compliance | Description | Data | Compliance | Description | Data |
|---|---|---|---|---|---|
| No | Landing Length (in) | N/A | Yes | DWS Provided? | Yes |
| No | Landing Width (in) | N/A | Yes | DWS Contrast? | Yes |
| No | Landing Slope (%) | N/A | Yes | DWS Length (in) | 24.5 |
| No | Landing X Slope (%) | N/A | No | DWS Full Width? | No |
| N/A | Landing Curb? (Y/N) | No | No | DWS Offset (in) | 5.0 |

Remove & Replace Entire Ramp.
