Access Compliance Report

Public Rights-of-Way

(Curb Ramps)

Intersection ID: 17688	Main Street: N_SHARON_AMITY_RD	Cross Street: WHITBY_LN	Location: W
ADA ID: 678958B33242	Ramp Type: PerpDiag	Initial Pass/Fail: Fail	Overall Compliance: No
Codes/Mitigation Info/Possible Solution		Field Measurements/Component Compliance	
Severity Score: 18.75

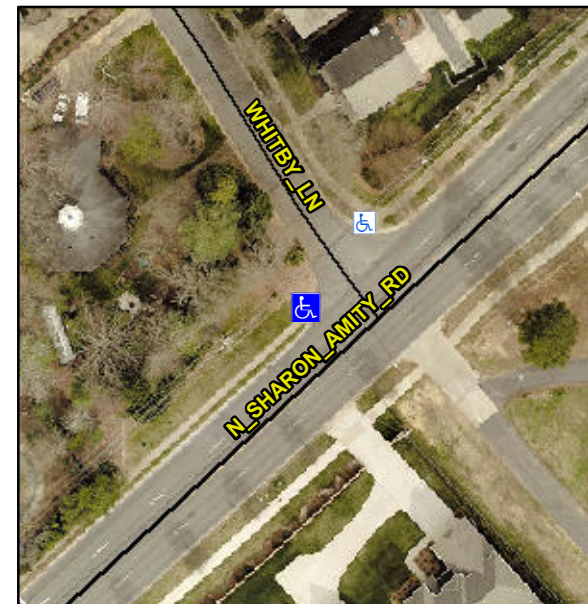
Not Found, R304.5.1, R304.5.3

Compliance	Description	Data	Compliance	Description	Data
N/A	Ramp Length (in)	62.0	Yes	Ramp Slope (%)	7.9
No	Ramp Width (in)	33.0	No	Ramp XSlope (%)	4.4
N/A	Flare Type LT	N/A	N/A	Flare Type RT	N/A
N/A	Flare Slope LT (%)	N/A	N/A	Flare Slope RT (%)	N/A
N/A	Flare Traversable LT?	N/A	N/A	Flare Traversable RT?	N/A
N/A	Landing Length (in)	N/A	N/A	DWS Provided?	N/A
N/A	Landing Width (in)	N/A	N/A	DWS Contrast?	N/A
N/A	Landing Slope (%)	N/A	N/A	DWS Length (in)	N/A
N/A	Landing X Slope (%)	N/A	N/A	DWS Full Width?	N/A
N/A	Landing Curb? (Y/N)	N/A	N/A	DWS Offset (in)	N/A
N/A	Shared Landing?	N/A			
N/A	Gutter Ponding?	N/A	N/A	Gutter Slope (%)	N/A
N/A	Gutter Lip Ht (in)	N/A	N/A	Gutter X Slope (%)	N/A
N/A	Painted X Walk1?	No	N/A	Painted X Walk2?	No
	X Walk 1 Direction	To SE		X Walk 2 Direction	To NE
N/A	X Walk 1 Width (in)	N/A	N/A	X Walk 2 Width (in)	N/A
	X Walk 1 Slope (%)	2.3		X Walk 2 Slope (%)	2.2
	X Walk 1 X Slope (%)	2.5		X Walk 2 X Slope (%)	1.4

N/A	Ramp inside XWalk1?	N/A	N/A	Ramp inside XWalk2?	N/A
	Road Slope (%)	0.2	N/A	Clear Space?	N/A
	Road X Slope (%)	3.8	N/A	Clear Space to XWalk (in)	N/A
N/A	Any Obstructions?	N/A	N/A	Storm Grate/Utility Hazard?	N/A
	Obstruction Type			Storm Grate/Utility Type	
		N/A			N/A
			Yes	Surface Condition? (G/P)	Good

Possible Solutions:

Remove & Replace Curb Ramp With Two New Directional Ramps or Equivalent.
