Access Compliance Report

Public Rights-of-Way

(Curb Ramps)

Intersection ID: 49933	Main Street: MARVIN_RD	Cross Street: WOBURN_RD	Location: NE
ADA ID: 6799832438C5	Ramp Type: Perp	Initial Pass/Fail: Fail	Overall Compliance: No
Severity Score: 37.5			
Codes/Mitigation Info/Possible Solution		Field Measurements/Component Compliance

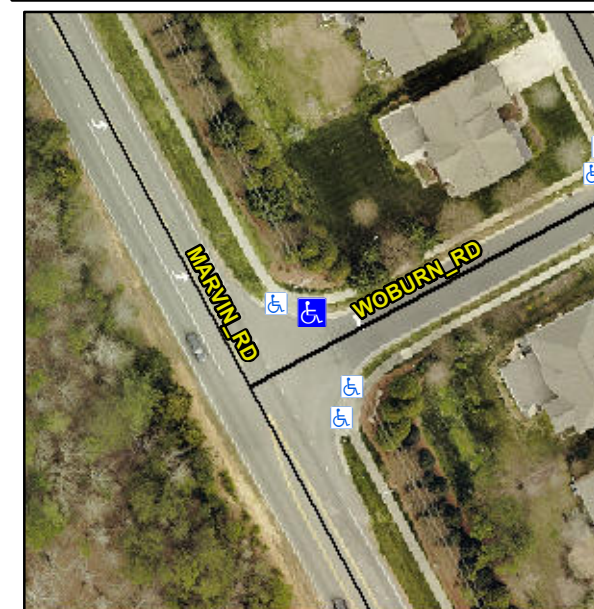
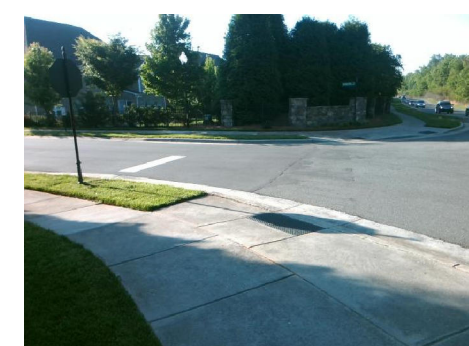
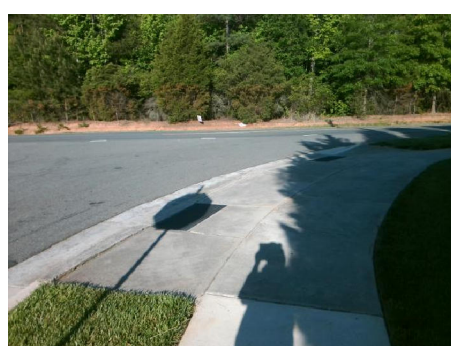
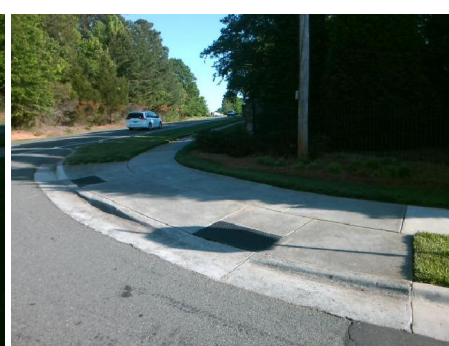
Compliance	Description	Data	Compliance	Description	Data
N/A	Ramp Length (in)	59.0	No	Ramp Slope (%)	9.1
Yes	Ramp Width (in)	48.0	No	Ramp XSlope (%)	8.0
N/A	Flare Type LT	N/A	N/A	Flare Type RT	N/A
N/A	Flare Slope LT (%)	N/A	N/A	Flare Slope RT (%)	N/A
N/A	Flare Traversable LT?	N/A	N/A	Flare Traversable RT?	N/A
N/A	Landing Length (in)	N/A	N/A	DWS Provided?	N/A
N/A	Landing Width (in)	N/A	N/A	DWS Contrast?	N/A
N/A	Landing Slope (%)	N/A	N/A	DWS Length (in)	N/A
N/A	Landing X Slope (%)	N/A	N/A	DWS Full Width?	N/A
N/A	Landing Curb? (Y/N)	N/A	N/A	DWS Offset (in)	N/A
N/A	Shared Landing?	N/A			
N/A	Gutter Ponding?	N/A	N/A	Gutter Slope (%)	N/A
N/A	Gutter Lip Ht (in)	N/A	N/A	Gutter X Slope (%)	N/A
N/A	Painted X Walk1?	No	N/A	Painted X Walk2?	N/A
	X Walk 1 Direction	To SE		X Walk 2 Direction	N/A
N/A	X Walk 1 Width (in)	N/A	N/A	X Walk 2 Width (in)	N/A
	X Walk 1 Slope (%)	2.0		X Walk 2 Slope (%)	N/A
	X Walk 1 X Slope (%)	5.8		X Walk 2 X Slope (%)	N/A

N/A	Ramp inside XWalk1?	N/A	N/A	Ramp inside XWalk2?	N/A
	Road Slope (%)	N/A	N/A	Clear Space?	N/A
	Road X Slope (%)	N/A	N/A	Clear Space to XWalk (in)	N/A
N/A	Any Obstructions?	N/A	N/A	Storm Grate/Utility Hazard?	N/A
	Obstruction Type			Storm Grate/Utility Type	
		N/A			N/A
			Yes	Surface Condition? (G/P)	Good

Possible Solutions:

Remove & Replace Entire Ramp.

R304.2.2, R304.5.3
