Access Compliance Report Public Rights-of-Way (Curb Ramps)

Intersection ID: 18386 Main Street: E_W_T_HARRIS_BV Cross Street: LAURA_DR Location: SW **Overall Compliance: No** ADA ID: 6799B5460A10 Ramp Type: Perp Initial Pass/Fail: Fail Severity Score: 21.25

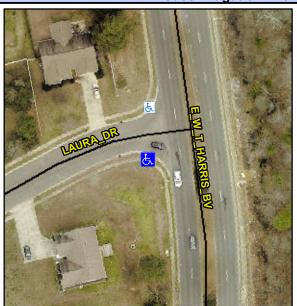
Field Measurements/Component Compliance							
Compl	liance Description	Data	Comp	liance	Description	Data	
N/A	Ramp Length (in)	46.0	No	Ramp	Slope (%)	9.5	
No	Ramp Width (in)	43.0	Yes	Ramp	XSlope (%)	1.1	
N/A	Flare Type LT	N/A	N/A	Flare	Type RT	N/A	
N/A	Flare Slope LT (%)	N/A	N/A	Flare	Slope RT (%)	N/A	
N/A	Flare Traversable LT?	N/A	N/A	Flare	Traversable RT?	N/A	
N/A	Landing Length (in)	N/A	N/A	DWS	Provided?	N/A	
N/A	Landing Width (in)	N/A	N/A	DWS	Contrast?	N/A	
N/A	Landing Slope (%)	N/A	N/A	DWS	Length (in)	N/A	
N/A	Landing X Slope (%)	N/A	N/A	DWS	Full Width?	N/A	
N/A	Landing Curb? (Y/N)	N/A	N/A	DWS	Offset (in)	N/A	
N/A	Shared Landing?	N/A					
N/A	Gutter Ponding?	N/A	N/A	Gutte	r Slope (%)	N/A	
N/A	Gutter Lip Ht (in)	N/A	N/A	Gutte	r X Slope (%)	N/A	
N/A	Painted X Walk1?	No	N/A	Painte	ed X Walk2?	N/A	
	X Walk 1 Direction	To N		X Wa	lk 2 Direction	N/A	
N/A	X Walk 1 Width (in)	N/A	N/A	X Wa	lk 2 Width (in)	N/A

X Walk 1 Slope (%)	5.7		X Wa	lk 2 Slope (%)	N/A	
	X Walk 1 X Slope (%)	3.4		X Wa	lk 2 X Slope (%)	N/A	
N/A	Ramp inside XWalk1?	N/A	N/A	Ramp	inside XWalk2?	N/A	
	Road Slope (%)	N/A	N/A	Clear	Space?	N/A	
	Road X Slope (%)	N/A	N/A	Clear	Space to XWalk (in)	N/A	
N/A	Any Obstructions?	N/A	N/A	Storm	Grate/Utility Hazard?	N/A	
	Obstruction Type			Storm	Grate/Utility Type		
		N/A				N/A	
			Yes	Surfa	ce Condition? (G/P)	Good

OSSIDIE SOIULION	
Possible Solutions:	Col
Remove & Replace Entire Ramp.	N/A
·	No
	N/A
	N/A
	N/A
	N/A
Surveyor Notes:	N/A
N/A	N/A
	N/A
	N/A
	N/A
PROW/ADA:	N/A
R304.5.1, R304.2.2	N/A
,	N/A
	N/A
	N/A
