## **Access Compliance Report Public Rights-of-Way** (Curb Ramps)

Intersection ID: 20865 Main Street: SIMSBURY RD Cross Street: VALENCIA\_TR Location: NE ADA ID: 67B3EB86BE38 Ramp Type: PerpDiag Initial Pass/Fail: Fail **Overall Compliance: No** Severity Score: 21.25

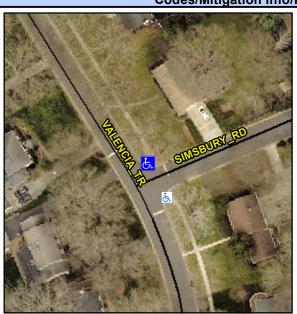
Compliance Description		Data	Compliance Description		Data
N/A	Ramp Length (in)	42.5	Yes	Ramp Slope (%)	5.5
No	Ramp Width (in)	39.5	No	Ramp XSlope (%)	6.6
N/A	Flare Type LT	N/A	N/A	Flare Type RT	N/A
N/A	Flare Slope LT (%)	N/A	N/A	Flare Slope RT (%)	N/A
N/A	Flare Traversable LT?	N/A	N/A	Flare Traversable RT?	N/A
N/A	Landing Length (in)	N/A	N/A	DWS Provided?	N/A
N/A	Landing Width (in)	N/A	N/A	DWS Contrast?	N/A
N/A	Landing Slope (%)	N/A	N/A	DWS Length (in)	N/A
N/A	Landing X Slope (%)	N/A	N/A	DWS Full Width?	N/A
N/A	Landing Curb? (Y/N)	N/A	N/A	DWS Offset (in)	N/A
N/A	Shared Landing?	N/A			
N/A	Gutter Ponding?	N/A	N/A	Gutter Slope (%)	N/A
N/A	Gutter Lip Ht (in)	N/A	N/A	Gutter X Slope (%)	N/A
N/A	Painted X Walk1?	No	N/A	Painted X Walk2?	No
	X Walk 1 Direction	To W		X Walk 2 Direction	To S
N/A	X Walk 1 Width (in)	N/A	N/A	X Walk 2 Width (in)	N/A
	X Walk 1 Slope (%)	2.0		X Walk 2 Slope (%)	4.8
	X Walk 1 X Slope (%)	4.6		X Walk 2 X Slope (%)	0.4

N/A	Ramp inside XWalk1?	N/A	N/A	Ramp inside XWalk2?	N/A
	Road Slope (%)	1.6	N/A	Clear Space?	N/A
	Road X Slope (%)	5.8	N/A	Clear Space to XWalk (in)	N/A
N/A	Any Obstructions?	N/A	N/A	Storm Grate/Utility Hazard	? <b>N/A</b>
	Obstruction Type			Storm Grate/Utility Type	
		N/A			N/A

**VALENCIA TR** StopSign SIMSBURY RD Possible Solutions: Remove & Replace Curb Ramp With Two New Directional Ramps or Equivalent.
