# Access Compliance Report

## Public Rights-of-Way

### (Curb Ramps)

| Intersection ID: 31537 | Main Street: CARLEEN_WAY_DR | Cross Street: GRIER_SPRINGS_LN | Location: NW |

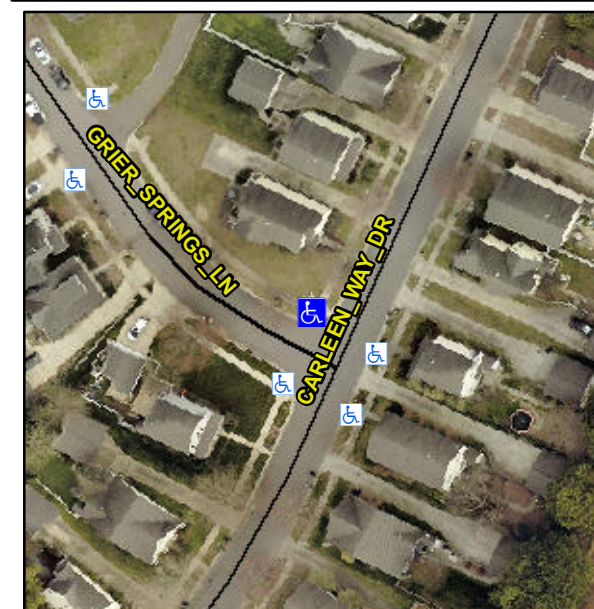
| ADA ID: 67B7E68F104B | Ramp Type: PerpDiag | Initial Pass/Fail: Fail | Overall Compliance: No |
| Severity Score: 12.5 | | | |

**Not Found, R304.5.3**

| Compliance | Description | Data | Compliance | Description | Data |
|---|---|---|---|---|---|
| N/A | Ramp Length (in) | 55.5 | Yes | Ramp Slope (%) | 7.1 |
| Yes | Ramp Width (in) | 48.5 | No | Ramp XSlope (%) | 5.6 |

**Remove & Replace Curb Ramp With Two New Directional Ramps or Equivalent.**

Total Cost: \$ 3200.00
