Access Compliance Report

Public Rights-of-Way

(Curb Ramps)

Intersection ID: 21445	Main Street: CHAMPAIGN_ST	Cross Street: COTILLION_AV	Location:	E
ADA ID: 67B851B25BC0	Ramp Type: Directional1	Initial Pass/Fail: Fail	Overall Compliance: No	Severity Score: 10
Codes/Mitigation Info/Possible Solution		Field Measurements/Component Compliance

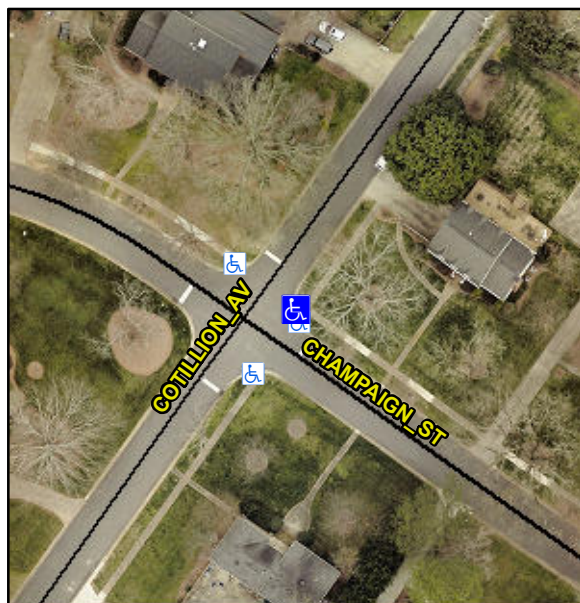
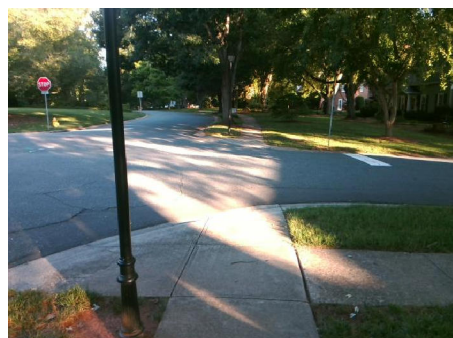
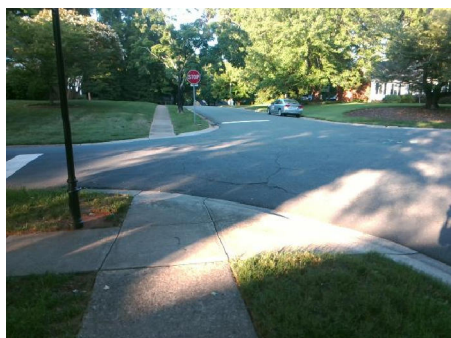
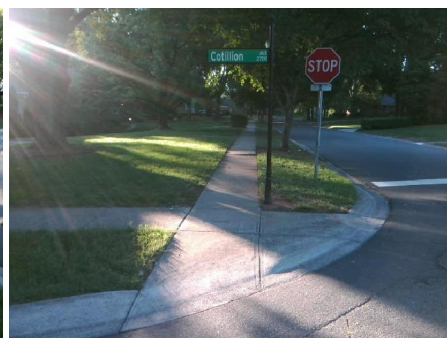
Compliance	Description	Data	Compliance	Description	Data
N/A	Ramp Length (in)	51.0	N/A	Grade Break?	N/A
No	Ramp Width (in)	45.5	N/A	Grade Break Slope (%)	0.0
Yes	Ramp Slope (%)	8.1	N/A	Grade Break XSlope (%)	0.0
No	Ramp XSlope (%)	3.0			
N/A	Flare Type LT	N/A	N/A	Flare Type RT	N/A
N/A	Flare Slope LT (%)	N/A	N/A	Flare Slope RT (%)	0.0
N/A	Flare Traversable LT?	N/A	N/A	Flare Traversable RT?	N/A
N/A	Landing Length (in)	0.0	N/A	DWS Provided?	N/A
N/A	Landing Width (in)	0.0	N/A	DWS Contrast?	N/A
N/A	Landing Slope (%)	0.0	N/A	DWS Length (in)	N/A
N/A	Landing X Slope (%)	0.0	N/A	DWS Full Width?	N/A
N/A	Landing Curb? (Y/N)	N/A	N/A	DWS Offset LT (in)	N/A
N/A	Shared Landing?	N/A	N/A	DWS Offset RT (in)	N/A
N/A	Gutter Ponding?	0.0	N/A	Gutter Slope (%)	N/A
N/A	Gutter Lip Ht (in)	0.0	N/A	Gutter X Slope (%)	N/A
N/A	Painted X Walk1?	No		Road Slope (%)	6.6
	X Walk 1 Direction	To W		Road X Slope (%)	3.4
	X Walk 1 Width (in)	N/A		Clear Space?	N/A

X Walk 1 Slope (%)	6.6	N/A	Clear Space to XWalk (in)	N/A
	X Walk 1 X Slope (%)	3.4	N/A	Storm Grate/Utility Hazard?	N/A
N/A	Ramp inside XWalk1?	N/A		Storm Grate/Utility Type	
N/A	Any Obstructions?	N/A			N/A
	Obstruction Type		Yes	Surface Condition? (G/P)	Good
			N/A	Curb Slope (%)	2.2

Remove & Replace Entire Ramp.

R304.5.1, R304.5.3
