## **Access Compliance Report Public Rights-of-Way** (Curb Ramps)

Intersection ID: 10617 Main Street: STATE ST **Cross Street: WHITEHAVEN AV** Location: SE **Overall Compliance: No Severity Score:** 35 **ADA ID: 67B993AA0AE4** Ramp Type: PerpDiag Initial Pass/Fail: Fail

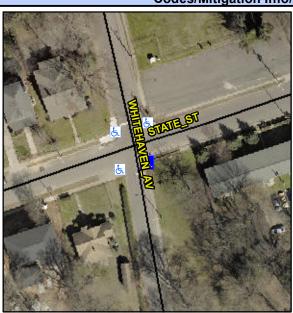
Compliance Description Data Compliance Description Data Yes Ramp Slope (%) Ramp Length (in) 49.5 8.1 Yes Ramp XSlope (%) Ramp Width (in) 24.0 0.0 N/A Flare Type LT N/A Flare Type RT N/A N/A N/A Flare Slope RT (%) N/A Flare Slope LT (%) Flare Traversable LT? N/A N/A Flare Traversable RT? N/A N/A N/A **DWS Provided?** N/A Landing Length (in) Landing Width (in) N/A N/A **DWS Contrast?** N/A N/A N/A DWS Length (in) N/A N/A N/A DWS Full Width? N/A N/A N/A DWS Offset (in) N/A N/A N/A N/A Gutter Slope (%) N/A N/A N/A Gutter X Slope (%) N/A No N/A Painted X Walk2? No To N X Walk 2 Direction To W N/A X Walk 2 Width (in) N/A 5.7 X Walk 2 Slope (%) 7.2 X Walk 2 X Slope (%) 4.6 3.8 N/A N/A Ramp inside XWalk2? N/A 0.1 N/A Clear Space? N/A N/A 8.2 Clear Space to XWalk (in) N/A N/A N/A Storm Grate/Utility Hazard? N/A Storm Grate/Utility Type N/A N/A Yes Surface Condition? (G/P) Good

STATE ST Street 1 Name Stop Condition-Street 2 None WHITEHAVEN AV Street 2 Name Stop Condition-Street 1 StopSign Possible Solutions: N/A Remove & Replace Curb Ramp With Two New Directional Ramps or No Equivalent. Surveyor Notes: N/A PROW/ADA: Not Found, R304.5.1
