Access Compliance Report

Public Rights-of-Way

(Curb Ramps)

Intersection ID: 42456	Main Street: SUNNINGHILL_PARK_RD	Cross Street: KINGSLEY_VIEW_DR	Location: SW
ADA ID: 67BD6F5F2F3E	Ramp Type: Perp	Initial Pass/Fail: Fail	Overall Compliance: No
Severity Score: 37.5			
Codes/Mitigation Info/Possible Solution		Field Measurements/Component Compliance

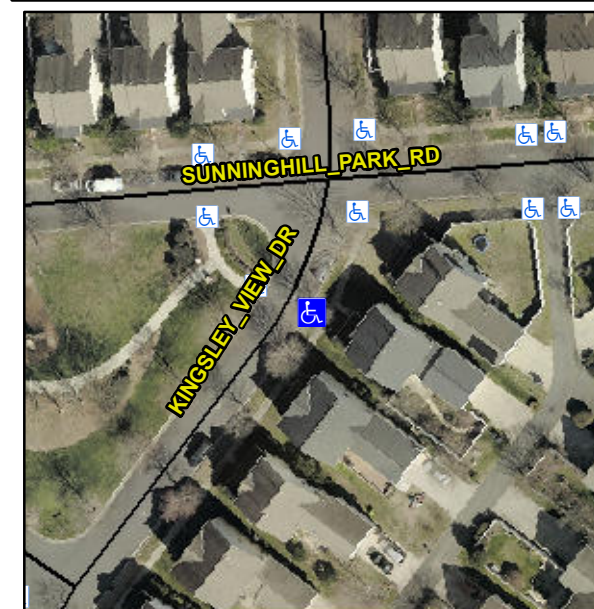
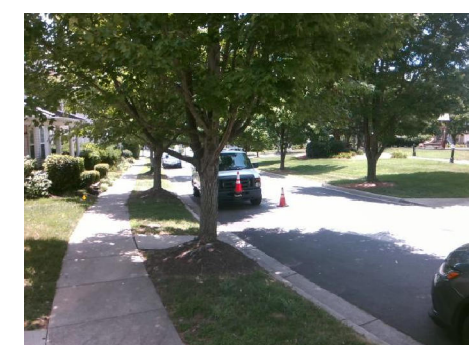
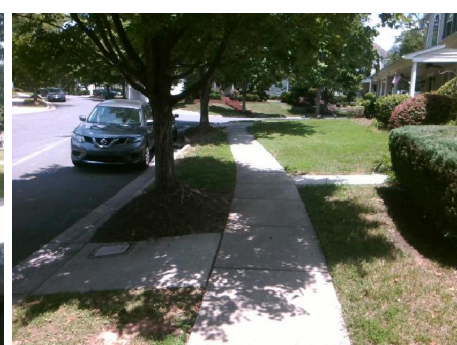
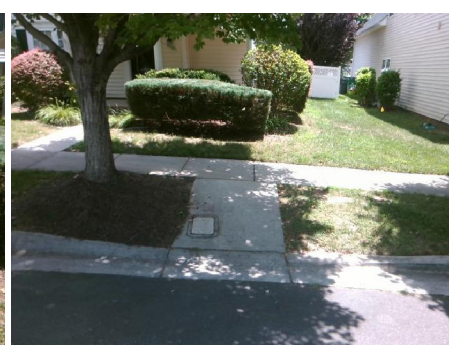
Not Found, R304.2.2, R304.5.3

Compliance	Description	Data	Compliance	Description	Data
N/A	Ramp Length (in)	96.0	No	Ramp Slope (%)	15.5
Yes	Ramp Width (in)	50.0	No	Ramp XSlope (%)	6.2
N/A	Flare Type LT	N/A	N/A	Flare Type RT	N/A
N/A	Flare Slope LT (%)	N/A	N/A	Flare Slope RT (%)	N/A
N/A	Flare Traversable LT?	N/A	N/A	Flare Traversable RT?	N/A
N/A	Landing Length (in)	N/A	N/A	DWS Provided?	N/A
N/A	Landing Width (in)	N/A	N/A	DWS Contrast?	N/A
N/A	Landing Slope (%)	N/A	N/A	DWS Length (in)	N/A
N/A	Landing X Slope (%)	N/A	N/A	DWS Full Width?	N/A
N/A	Landing Curb? (Y/N)	N/A	N/A	DWS Offset (in)	N/A
N/A	Shared Landing?	N/A			
N/A	Gutter Ponding?	N/A	N/A	Gutter Slope (%)	N/A
N/A	Gutter Lip Ht (in)	N/A	N/A	Gutter X Slope (%)	N/A
N/A	Painted X Walk1?	No	N/A	Painted X Walk2?	N/A
	X Walk 1 Direction	To NW		X Walk 2 Direction	N/A
N/A	X Walk 1 Width (in)	N/A	N/A	X Walk 2 Width (in)	N/A
	X Walk 1 Slope (%)	3.2		X Walk 2 Slope (%)	N/A
	X Walk 1 X Slope (%)	5.0		X Walk 2 X Slope (%)	N/A

N/A	Ramp inside XWalk1?	N/A	N/A	Ramp inside XWalk2?	N/A
	Road Slope (%)	N/A	N/A	Clear Space?	N/A
	Road X Slope (%)	N/A	N/A	Clear Space to XWalk (in)	N/A
N/A	Any Obstructions?	N/A	N/A	Storm Grate/Utility Hazard?	N/A
	Obstruction Type			Storm Grate/Utility Type	
		N/A			N/A
			Yes	Surface Condition? (G/P)	Good

Remove & Replace Entire Ramp.

Total Cost: \$ 1850.00
