Access Compliance Report

Public Rights-of-Way

(Curb Ramps)

Intersection ID: 3579	Main Street: KENT_VILLAGE_DR	Cross Street: SAXONBURY_WY	Location: E
ADA ID: 67C041B53B4D	Ramp Type: Perp	Initial Pass/Fail: Fail	Overall Compliance: No
Codes/Mitigation Info/Possible Solution		Field Measurements/Component Compliance

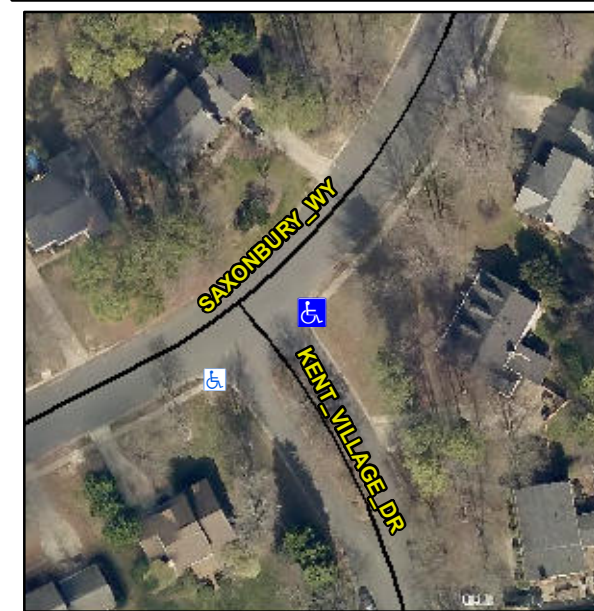
Not Found, R304.5.1, R304.2.2

Compliance	Description	Data	Compliance	Description	Data
N/A	Ramp Length (in)	52.5	No	Ramp Slope (%)	8.4
No	Ramp Width (in)	47.5	Yes	Ramp XSlope (%)	0.8
N/A	Flare Type LT	N/A	N/A	Flare Type RT	N/A
N/A	Flare Slope LT (%)	N/A	N/A	Flare Slope RT (%)	N/A
N/A	Flare Traversable LT?	N/A	N/A	Flare Traversable RT?	N/A
N/A	Landing Length (in)	N/A	N/A	DWS Provided?	N/A
N/A	Landing Width (in)	N/A	N/A	DWS Contrast?	N/A
N/A	Landing Slope (%)	N/A	N/A	DWS Length (in)	N/A
N/A	Landing X Slope (%)	N/A	N/A	DWS Full Width?	N/A
N/A	Landing Curb? (Y/N)	N/A	N/A	DWS Offset (in)	N/A
N/A	Shared Landing?	N/A			
N/A	Gutter Ponding?	N/A	N/A	Gutter Slope (%)	N/A
N/A	Gutter Lip Ht (in)	N/A	N/A	Gutter X Slope (%)	N/A
N/A	Painted X Walk1?	No	N/A	Painted X Walk2?	N/A
	X Walk 1 Direction	To SW		X Walk 2 Direction	N/A
N/A	X Walk 1 Width (in)	N/A	N/A	X Walk 2 Width (in)	N/A
	X Walk 1 Slope (%)	1.5		X Walk 2 Slope (%)	N/A
	X Walk 1 X Slope (%)	1.1		X Walk 2 X Slope (%)	N/A

N/A	Ramp inside XWalk1?	N/A	N/A	Ramp inside XWalk2?	N/A
	Road Slope (%)	N/A	N/A	Clear Space?	N/A
	Road X Slope (%)	N/A	N/A	Clear Space to XWalk (in)	N/A
N/A	Any Obstructions?	N/A	N/A	Storm Grate/Utility Hazard?	N/A
	Obstruction Type			Storm Grate/Utility Type	
		N/A			N/A
			Yes	Surface Condition? (G/P)	Good

Possible Solutions:

Remove & Replace Entire Ramp.
