# Access Compliance Report

## Public Rights-of-Way (Curb Ramps)

| Intersection ID: 10040083 | Main Street: TUCKASEEGEE_RD | Cross Street: N/A | Location: S |
| ADA ID: 67C756231E7D | Ramp Type: Directional1 | Initial Pass/Fail: Fail | Overall Compliance: No |

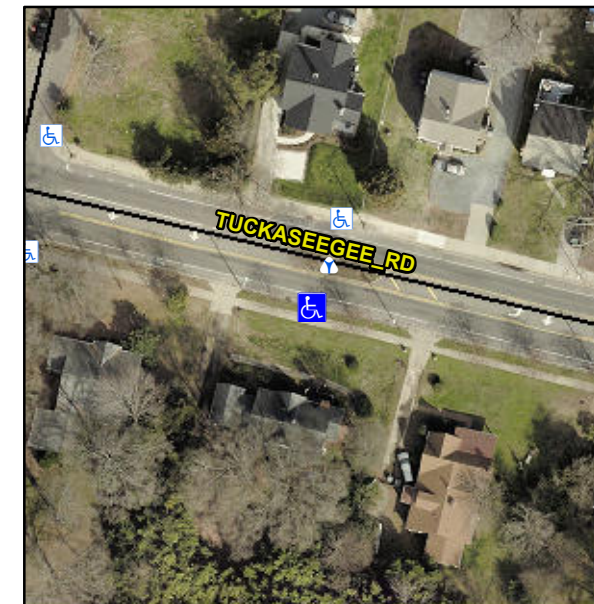
| | | | Severity Score: 33.75 |

**R304.5.1, R304.2.2**

| Compliance | Description | Data | Compliance | Description | Data |
|---|---|---|---|---|---|
| No | Ramp Width (in) | 46.5 | N/A | Grade Break Slope (%) | 0.0 |
| No | Ramp Slope (%) | 13.4 | N/A | Grade Break XSlope (%) | 0.0 |

**Remove & Replace Entire Ramp.**

Total Cost: \$ 1600.00
