Access Compliance Report

Public Rights-of-Way

(Curb Ramps)

Intersection ID: 16663	Main Street: BUCKNELL_AV	Cross Street: PRINCETON_AV	Location: SE
ADA ID: 67CAD100D11C	Ramp Type: PerpDiag	Initial Pass/Fail: Fail	Overall Compliance: No
Codes/Mitigation Info/Possible Solution			Severity Score: 25
			Field Measurements/Component Compliance

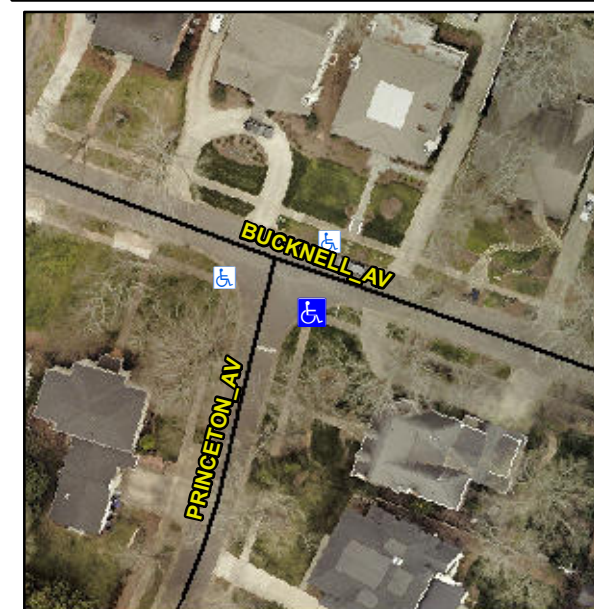
Compliance	Description	Data	Compliance	Description	Data
N/A	Ramp Length (in)	43.0	No	Ramp Slope (%)	15.0
Yes	Ramp Width (in)	48.0	Yes	Ramp XSlope (%)	1.5
N/A	Flare Type LT	N/A	N/A	Flare Type RT	N/A
N/A	Flare Slope LT (%)	N/A	N/A	Flare Slope RT (%)	N/A
N/A	Flare Traversable LT?	N/A	N/A	Flare Traversable RT?	N/A
N/A	Landing Length (in)	N/A	N/A	DWS Provided?	N/A
N/A	Landing Width (in)	N/A	N/A	DWS Contrast?	N/A
N/A	Landing Slope (%)	N/A	N/A	DWS Length (in)	N/A
N/A	Landing X Slope (%)	N/A	N/A	DWS Full Width?	N/A
N/A	Landing Curb? (Y/N)	N/A	N/A	DWS Offset (in)	N/A
N/A	Shared Landing?	N/A			
N/A	Gutter Ponding?	N/A	N/A	Gutter Slope (%)	N/A
N/A	Gutter Lip Ht (in)	N/A	N/A	Gutter X Slope (%)	N/A
N/A	Painted X Walk1?	No	N/A	Painted X Walk2?	No
	X Walk 1 Direction	To NE		X Walk 2 Direction	To NW
N/A	X Walk 1 Width (in)	N/A	N/A	X Walk 2 Width (in)	N/A
	X Walk 1 Slope (%)	7.3		X Walk 2 Slope (%)	3.4
	X Walk 1 X Slope (%)	0.7		X Walk 2 X Slope (%)	5.5

N/A	Ramp inside XWalk1?	N/A	N/A	Ramp inside XWalk2?	N/A
	Road Slope (%)	0.7	N/A	Clear Space?	N/A
	Road X Slope (%)	5.6	N/A	Clear Space to XWalk (in)	N/A
N/A	Any Obstructions?	N/A	N/A	Storm Grate/Utility Hazard?	N/A
	Obstruction Type			Storm Grate/Utility Type	
		N/A			N/A
			Yes	Surface Condition? (G/P)	Good

Possible Solutions:

Remove & Replace Curb Ramp With Two New Directional Ramps or Equivalent.

R304.2.2
