## Access Compliance Report Public Rights-of-Way (Curb Ramps)

Intersection ID: 7466 Main Street: S\_I-85\_EXIT\_39\_RA Cross Street: STATESVILLE\_RD Location: SW

ADA ID: 67D54E6A2B6E Ramp Type: Perp Initial Pass/Fail: Pass Overall Compliance: No Severity Score: 10

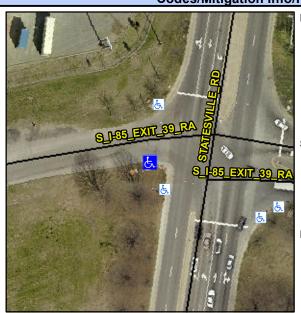
Not Found, R304.2.1, R304.2.2-Perp, R304.3.2-Para, R304.5.3, R305

Field Measurements/Component Compliance					
Comp	liance Description	Data	Comp	liance Description	Data
N/A	Ramp Length (in)	33.0	Yes	Ramp Slope (%)	5.8
Yes	Ramp Width (in)	58.0	Yes	Ramp XSlope (%)	0.5
N/A	Flare Type LT	Sloped	N/A	Flare Type RT	N/A
N/A	Flare Slope LT (%)	4.0	N/A	Flare Slope RT (%)	5.0
N/A	Flare Traversable LT?	Yes	N/A	Flare Traversable RT?	No
No	Landing Length (in)	35.0	No	DWS Provided?	No
Yes	Landing Width (in)	58.0	N/A	DWS Contrast?	No
No	Landing Slope (%)	3.5	N/A	DWS Length (in)	N/A
No	Landing X Slope (%)	2.1	N/A	DWS Full Width?	No
N/A	Landing Curb? (Y/N)	No	N/A	DWS Offset (in)	N/A
N/A	Shared Landing?	No			
Yes	Gutter Ponding?	No	Yes	Gutter Slope (%)	3.6
Yes	Gutter Lip Ht (in)	0.0	Yes	Gutter X Slope (%)	0.7
N/A	Painted X Walk1?	No	N/A	Painted X Walk2?	N/A
	X Walk 1 Direction	To N		X Walk 2 Direction	N/A
N/A	X Walk 1 Width (in)	N/A	N/A	X Walk 2 Width (in)	N/A
	X Walk 1 Slope (%)	0.4		X Walk 2 Slope (%)	N/A

X Walk 1 X Slope (%)	0.7		X Walk 2 X Slope (%)	N/A
N/A	Ramp inside XWalk1?	N/A	N/A	Ramp inside XWalk2?	N/A
	Road Slope (%)	N/A	N/A	Clear Space?	Yes
	Road X Slope (%)	N/A	N/A	Clear Space to XWalk (in)	N/A
Yes	Any Obstructions?	No	Yes	Storm Grate/Utility Hazard?	No
	Obstruction Type			Storm Grate/Utility Type	
		N/A			N/A
			Yes	Surface Condition? (G/P)	Good

Remove & Replace Entire Ramp.
