# Access Compliance Report

## Public Rights-of-Way

### (Curb Ramps)

Intersection ID: 25441	Main Street: PROVIDENCE PLANTATION LN	Cross Street: PROVIDENCE SPRING LN	Location: N
ADA ID: 67D6A6452457	Ramp Type: PerpDiag	Initial Pass/Fail: Fail	Overall Compliance: No
Severity Score: 13.75			
Codes/Mitigation Info/Possible Solution		Field Measurements/Component Compliance

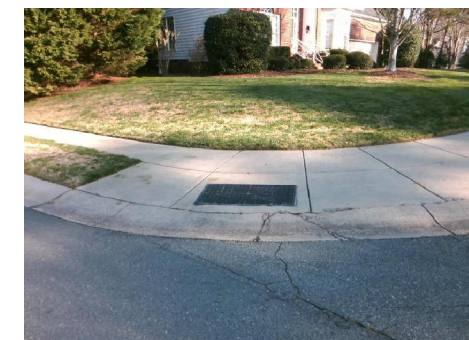
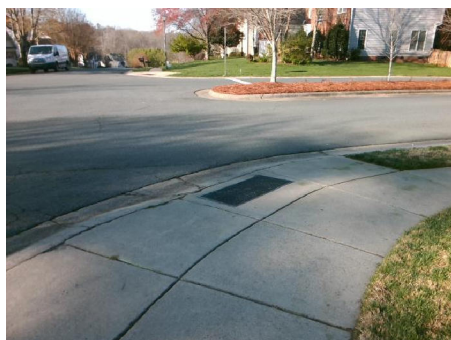
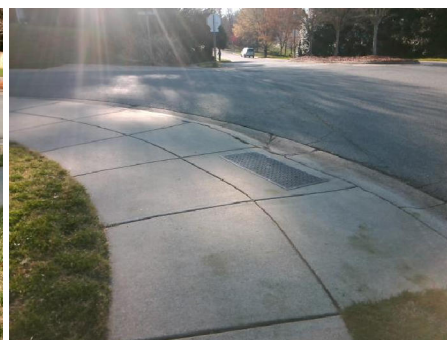
**Not Found, R304.2.2, R304.5.3**

Compliance	Description	Data	Compliance	Description	Data
N/A	Ramp Length (in)	48.0	No	Ramp Slope (%)	9.5
Yes	Ramp Width (in)	53.5	No	Ramp XSlope (%)	2.8
N/A	Flare Type LT	N/A	N/A	Flare Type RT	N/A
N/A	Flare Slope LT (%)	N/A	N/A	Flare Slope RT (%)	N/A
N/A	Flare Traversable LT?	N/A	N/A	Flare Traversable RT?	N/A
N/A	Landing Length (in)	N/A	N/A	DWS Provided?	N/A
N/A	Landing Width (in)	N/A	N/A	DWS Contrast?	N/A
N/A	Landing Slope (%)	N/A	N/A	DWS Length (in)	N/A
N/A	Landing X Slope (%)	N/A	N/A	DWS Full Width?	N/A
N/A	Landing Curb? (Y/N)	N/A	N/A	DWS Offset (in)	N/A
N/A	Shared Landing?	N/A			
N/A	Gutter Ponding?	N/A	N/A	Gutter Slope (%)	N/A
N/A	Gutter Lip Ht (in)	N/A	N/A	Gutter X Slope (%)	N/A
N/A	Painted X Walk1?	No	N/A	Painted X Walk2?	No
	X Walk 1 Direction	To SW		X Walk 2 Direction	To SE
N/A	X Walk 1 Width (in)	N/A	N/A	X Walk 2 Width (in)	N/A
	X Walk 1 Slope (%)	0.6		X Walk 2 Slope (%)	2.5
	X Walk 1 X Slope (%)	2.0		X Walk 2 X Slope (%)	1.3

N/A	Ramp inside XWalk1?	N/A	N/A	Ramp inside XWalk2?	N/A
	Road Slope (%)	1.9	N/A	Clear Space?	N/A
	Road X Slope (%)	1.1	N/A	Clear Space to XWalk (in)	N/A
N/A	Any Obstructions?	N/A	N/A	Storm Grate/Utility Hazard?	N/A
	Obstruction Type			Storm Grate/Utility Type	
		N/A			N/A
			Yes	Surface Condition? (G/P)	Good

**Remove & Replace Curb Ramp With Two New Directional Ramps or Equivalent.**
