Access Compliance Report

Public Rights-of-Way

(Curb Ramps)

Intersection ID: 28373	Main Street: ASTOR_HALL_DR	Cross Street: SOUTHAMPTON_COMMONS_DR	Location: NE
ADA ID: 67E390A05026	Ramp Type: Perp	Initial Pass/Fail: Fail	Overall Compliance: No
Severity Score: 12.5			
Codes/Mitigation Info/Possible Solution		Field Measurements/Component Compliance

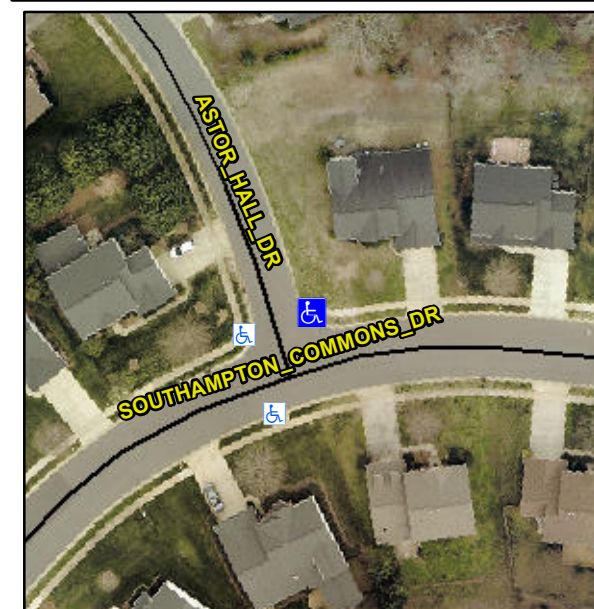
Not Found, R304.5.3

Compliance	Description	Data	Compliance	Description	Data
N/A	Ramp Length (in)	51.0	Yes	Ramp Slope (%)	5.1
Yes	Ramp Width (in)	48.0	No	Ramp XSlope (%)	6.7
N/A	Flare Type LT	N/A	N/A	Flare Type RT	N/A
N/A	Flare Slope LT (%)	N/A	N/A	Flare Slope RT (%)	N/A
N/A	Flare Traversable LT?	N/A	N/A	Flare Traversable RT?	N/A
N/A	Landing Length (in)	N/A	N/A	DWS Provided?	N/A
N/A	Landing Width (in)	N/A	N/A	DWS Contrast?	N/A
N/A	Landing Slope (%)	N/A	N/A	DWS Length (in)	N/A
N/A	Landing X Slope (%)	N/A	N/A	DWS Full Width?	N/A
N/A	Landing Curb? (Y/N)	N/A	N/A	DWS Offset (in)	N/A
N/A	Shared Landing?	N/A			
N/A	Gutter Ponding?	N/A	N/A	Gutter Slope (%)	N/A
N/A	Gutter Lip Ht (in)	N/A	N/A	Gutter X Slope (%)	N/A
N/A	Painted X Walk1?	No	N/A	Painted X Walk2?	N/A
	X Walk 1 Direction	To W		X Walk 2 Direction	N/A
N/A	X Walk 1 Width (in)	N/A	N/A	X Walk 2 Width (in)	N/A
	X Walk 1 Slope (%)	4.5		X Walk 2 Slope (%)	N/A
	X Walk 1 X Slope (%)	2.5		X Walk 2 X Slope (%)	N/A

N/A	Ramp inside XWalk1?	N/A	N/A	Ramp inside XWalk2?	N/A
	Road Slope (%)	N/A	N/A	Clear Space?	N/A
	Road X Slope (%)	N/A	N/A	Clear Space to XWalk (in)	N/A
N/A	Any Obstructions?	N/A	N/A	Storm Grate/Utility Hazard?	N/A
	Obstruction Type			Storm Grate/Utility Type	
		N/A			N/A
		Yes		Surface Condition? (G/P)	Good

Possible Solutions:

Remove & Replace Entire Ramp.
