# Access Compliance Report

## Public Rights-of-Way

### (Curb Ramps)

Intersection ID: 30279	Main Street: HAMPTON_WAY_DR	Cross Street: REAGAN_DR	Location: SE
ADA ID: 67E68293982E	Ramp Type: Combination2	Initial Pass/Fail: Fail	Overall Compliance: No
		Severity Score: 10

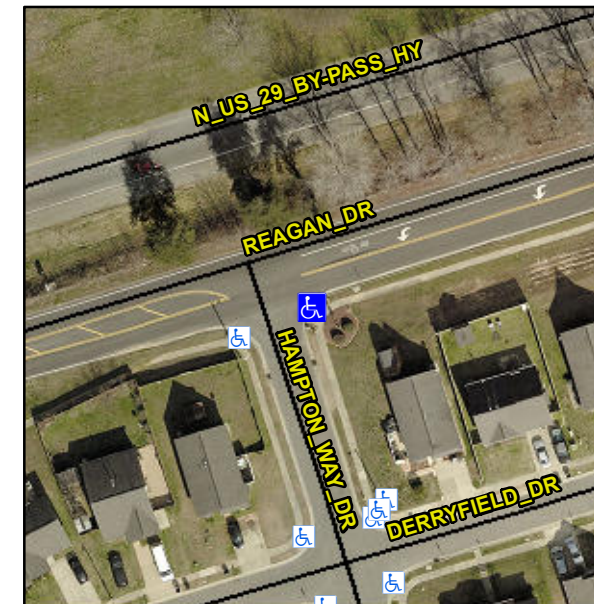
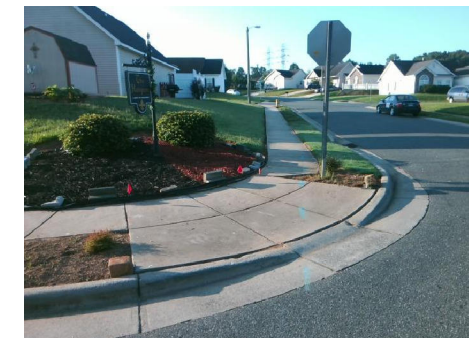
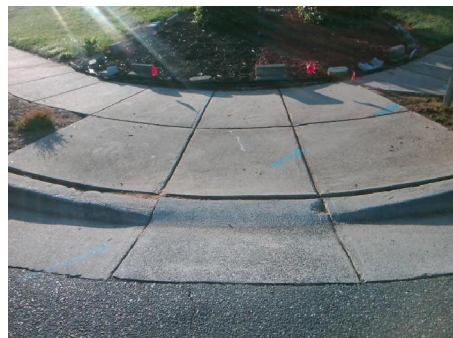
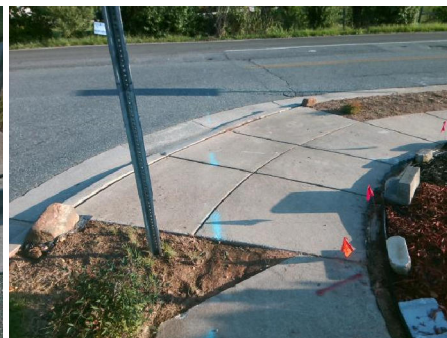
**LT RP < 5%**

**Not Found, R304.5.1, R304.5.3**

Compliance	Description	Data	Compliance	Description	Data
N/A	Ramp Length LT (in)	38.0	N/A	Ramp Length RT (in)	38.5
N/A	Ramp Width LT (in)	48.0	Yes	Ramp Width RT (in)	48.0
N/A	Ramp Slope LT (%)	1.7	Yes	Ramp Slope RT (%)	7.7
N/A	Ramp XSlope LT (%)	3.3	No	Ramp XSlope RT (%)	3.4
N/A	Ramp Length (in)	46.0	Yes	Ramp Slope (%)	5.0
No	Ramp Width (in)	39.0	No	Ramp XSlope (%)	3.9
N/A	Flare Type LT	N/A	N/A	Flare Type RT	N/A
N/A	Flare Slope LT (%)	N/A	N/A	Flare Slope RT (%)	N/A
N/A	Flare Traversable LT?	N/A	N/A	Flare Traversable RT?	N/A
N/A	Landing Length (in)	N/A	N/A	DWS Provided?	N/A
N/A	Landing Width (in)	N/A	N/A	DWS Contrast?	N/A
N/A	Landing Slope (%)	N/A	N/A	DWS Length (in)	N/A
N/A	Landing X Slope (%)	N/A	N/A	DWS Full Width?	N/A
N/A	Landing Curb? (Y/N)	N/A	N/A	DWS Offset (in)	N/A
N/A	Shared Landing?	N/A			
N/A	Gutter Ponding?	N/A	N/A	Gutter Slope (%)	N/A
N/A	Gutter Lip Ht (in)	N/A	N/A	Gutter X Slope (%)	N/A
N/A	Painted X Walk1?	No	N/A	Painted X Walk2?	N/A

X Walk 1 Direction	To W		X Walk 2 Direction	N/A
	X Walk 1 Width (in)	N/A		X Walk 2 Width (in)	N/A
	X Walk 1 Slope (%)	1.1		X Walk 2 Slope (%)	N/A
	X Walk 1 X Slope (%)	1.2		X Walk 2 X Slope (%)	N/A
N/A	Ramp inside XWalk1?	N/A	N/A	Ramp inside XWalk2?	N/A
	Road Slope (%)	N/A		Clear Space?	N/A
	Road X Slope (%)	N/A	N/A	Clear Space to XWalk (in)	N/A
			N/A	Any Obstruction?	N/A
				Obstruction Type	N/A
			N/A	Storm Grate/Utility Hazard?	N/A
				Storm Grate/Utility Type	N/A
			Yes	Surface Condition? (G/P)	Good
				Curb Slope (%)	14.6

**Remove & Replace Entire Ramp.**

Total Cost: \$ 1600.00
