Access Compliance Report

Public Rights-of-Way

(Curb Ramps)

Intersection ID: 14383	Main Street: CLEVELAND_AV	Cross Street: E TREMONT AV	Location:	N
ADA ID: 67F50B248BED	Ramp Type: Perp	Initial Pass/Fail: Fail	Overall Compliance: No	Severity Score: 13.75
Codes/Mitigation Info/Possible Solution		Field Measurements/Component Compliance

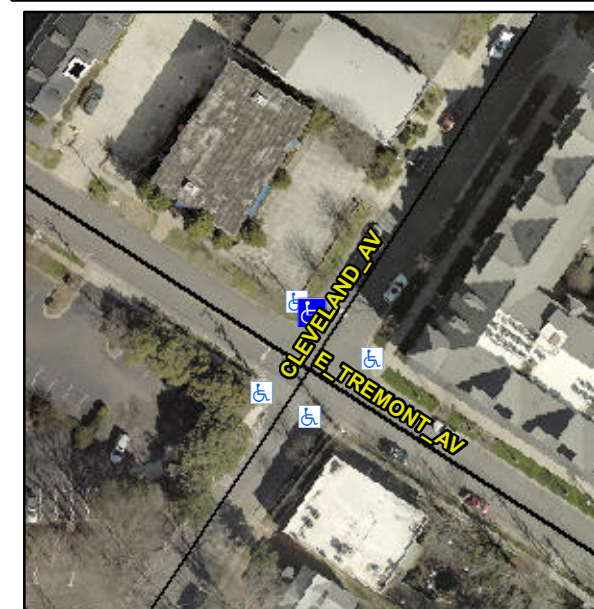
Not Found, R304.2.2, R304.5.3

Compliance	Description	Data	Compliance	Description	Data
N/A	Ramp Length (in)	66.0	No	Ramp Slope (%)	9.6
Yes	Ramp Width (in)	48.0	No	Ramp XSlope (%)	3.4
N/A	Flare Type LT	N/A	N/A	Flare Type RT	N/A
N/A	Flare Slope LT (%)	N/A	N/A	Flare Slope RT (%)	N/A
N/A	Flare Traversable LT?	N/A	N/A	Flare Traversable RT?	N/A
N/A	Landing Length (in)	N/A	N/A	DWS Provided?	N/A
N/A	Landing Width (in)	N/A	N/A	DWS Contrast?	N/A
N/A	Landing Slope (%)	N/A	N/A	DWS Length (in)	N/A
N/A	Landing X Slope (%)	N/A	N/A	DWS Full Width?	N/A
N/A	Landing Curb? (Y/N)	N/A	N/A	DWS Offset (in)	N/A
N/A	Shared Landing?	N/A			
N/A	Gutter Ponding?	N/A	N/A	Gutter Slope (%)	N/A
N/A	Gutter Lip Ht (in)	1.0	N/A	Gutter X Slope (%)	N/A
N/A	Painted X Walk1?	No	N/A	Painted X Walk2?	N/A
	X Walk 1 Direction	To SE		X Walk 2 Direction	N/A
N/A	X Walk 1 Width (in)	N/A	N/A	X Walk 2 Width (in)	N/A
	X Walk 1 Slope (%)	1.5		X Walk 2 Slope (%)	N/A
	X Walk 1 X Slope (%)	2.8		X Walk 2 X Slope (%)	N/A

N/A	Ramp inside XWalk1?	N/A	N/A	Ramp inside XWalk2?	N/A
	Road Slope (%)	N/A	N/A	Clear Space?	N/A
	Road X Slope (%)	N/A	N/A	Clear Space to XWalk (in)	N/A
N/A	Any Obstructions?	N/A	N/A	Storm Grate/Utility Hazard?	N/A
	Obstruction Type			Storm Grate/Utility Type	
		N/A			N/A
			Yes	Surface Condition? (G/P)	Good

Possible Solutions:

Remove & Replace Entire Ramp.
