# Access Compliance Report

## Public Rights-of-Way

### (Curb Ramps)

| Intersection ID: 5433 | Main Street: PLEASANT GROVE RD | Cross Street: OLD PLANK RD | Location: SE |

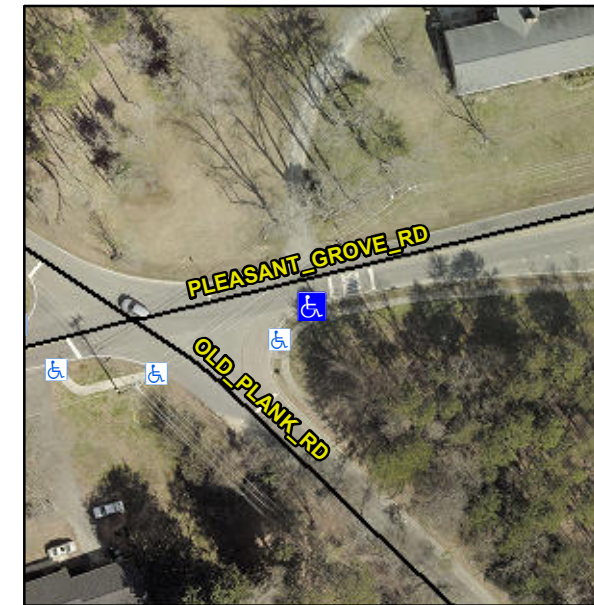
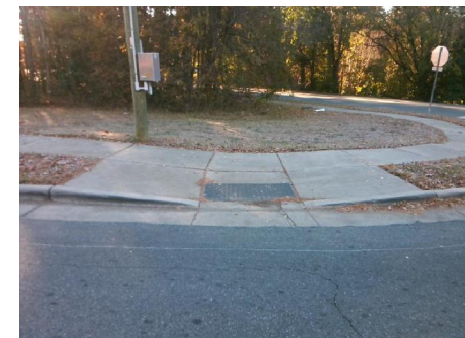
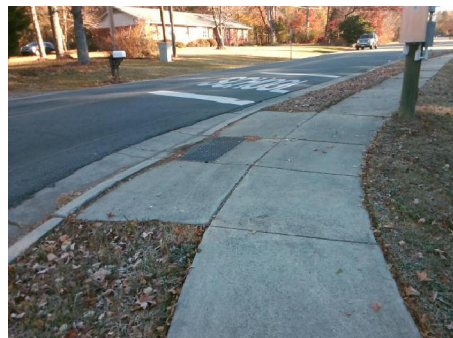
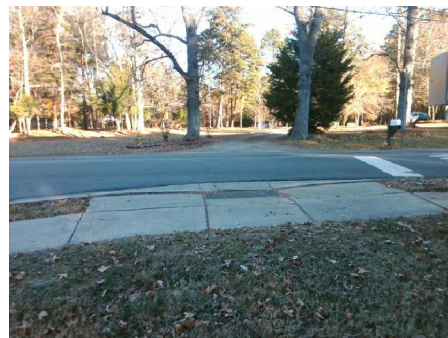
| | | | Severity Score: 12.75 |

**CRACK GTR, CURB LIP 0.5"**

**Not Found, R304.2.1, R304.5.3, R305.2, R302.7, R302.7.2, R304.5.4**

**Remove & Replace Curb Ramp With Two New Directional Ramps or Equivalent. Remove & Replace Gutter.**
