Access Compliance Report

Public Rights-of-Way

(Curb Ramps)

| Intersection ID: 50708 | Main Street: CELEBRATION_RD | Cross Street: BROTHERLY_LN | Location: NW |

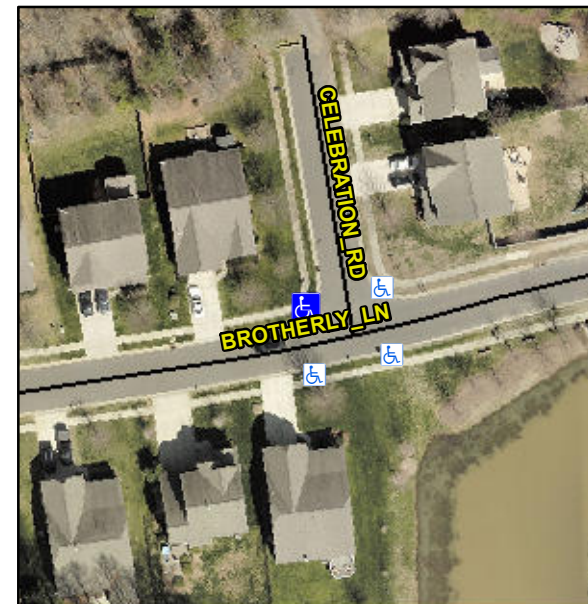
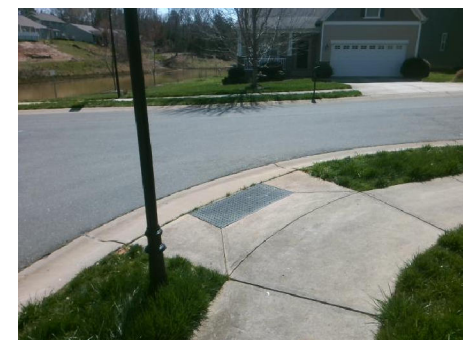
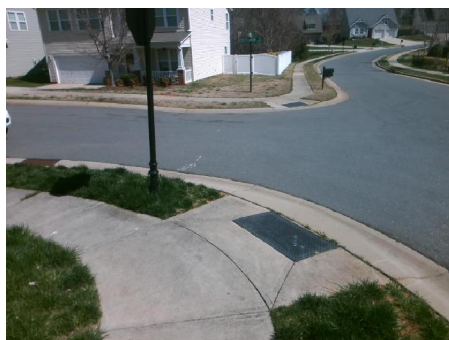
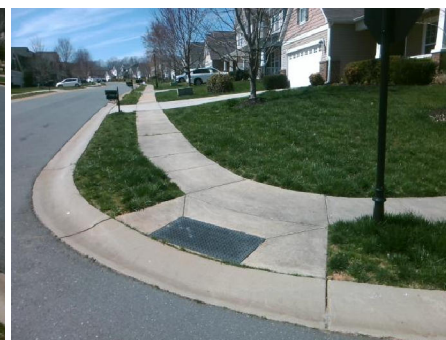
| ADA ID: 680A952D8ACE | Ramp Type: PerpDiag | Initial Pass/Fail: Fail | Overall Compliance: No |

| Compliance | Description | Data | Compliance | Description | Data |
|---|---|---|---|---|---|
| Yes | Ramp Width (in) | 48.0 | No | Ramp XSlope (%) | 5.6 |

Remove & Replace Curb Ramp With Two New Directional Ramps or Equivalent.
