Access Compliance Report Public Rights-of-Way (Curb Ramps)

Intersection ID: 43412 Main Street: PROVIDENCE CHURCH LN **Cross Street: PROVIDENCE RD** Location: SE ADA ID: 68110A1EDC3E Ramp Type: PerpDiag Initial Pass/Fail: Fail **Overall Compliance: No Severity Score:** 17.5

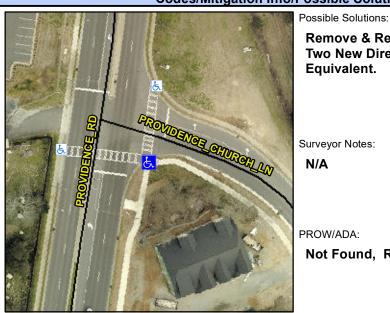
Field Measurements/Component Compnance					
Compliance Description		Data	Compliance Description		Data
N/A	Ramp Length (in)	86.0	Yes	Ramp Slope (%)	6.8
No	Ramp Width (in)	34.5	Yes	Ramp XSlope (%)	0.6
N/A	Flare Type LT	N/A	N/A	Flare Type RT	N/A
N/A	Flare Slope LT (%)	N/A	N/A	Flare Slope RT (%)	N/A
N/A	Flare Traversable LT?	N/A	N/A	Flare Traversable RT?	N/A
N/A	Landing Length (in)	N/A	N/A	DWS Provided?	N/A
N/A	Landing Width (in)	N/A	N/A	DWS Contrast?	N/A
N/A	Landing Slope (%)	N/A	N/A	DWS Length (in)	N/A
N/A	Landing X Slope (%)	N/A	N/A	DWS Full Width?	N/A
N/A	Landing Curb? (Y/N)	N/A	N/A	DWS Offset (in)	N/A
N/A	Shared Landing?	N/A			
N/A	Gutter Ponding?	N/A	N/A	Gutter Slope (%)	N/A
N/A	Gutter Lip Ht (in)	N/A	N/A	Gutter X Slope (%)	N/A
N/A	Painted X Walk1?	Yes	N/A	Painted X Walk2?	Yes
	X Walk 1 Direction	To N		X Walk 2 Direction	To W
N/A	X Walk 1 Width (in)	114.0	N/A	X Walk 2 Width (in)	105.5
	X Walk 1 Slope (%)	2.2		X Walk 2 Slope (%)	1.0

X Walk 1 X Slope (%)	0.6		X Walk 2 X Slope (%)	2.1
N/A	Ramp inside XWalk1?	Yes	N/A	Ramp inside XWalk2?	Yes
	Road Slope (%)	0.9	N/A	Clear Space?	N/A
	Road X Slope (%)	2.3	N/A	Clear Space to XWalk (in)	N/A
N/A	Any Obstructions?	N/A	N/A	Storm Grate/Utility Hazard?	N/A
	Obstruction Type			Storm Grate/Utility Type	
		N/A			N/A
			Yes	Surface Condition? (G/P)	Good

Two New Directional Ramps or Equivalent. Surveyor Notes: N/A

PROW/ADA: Not Found, R304.5.1

Remove & Replace Curb Ramp With
