Access Compliance Report

Public Rights-of-Way

(Curb Ramps)

Intersection ID: 15811	Main Street: BLAIRHILL_RD	Cross Street: S_TRYON_ST	Location: NW
ADA ID: 68119EB60267	Ramp Type: PerpDiag	Initial Pass/Fail: Fail	Overall Compliance: No
			Severity Score: 21.25

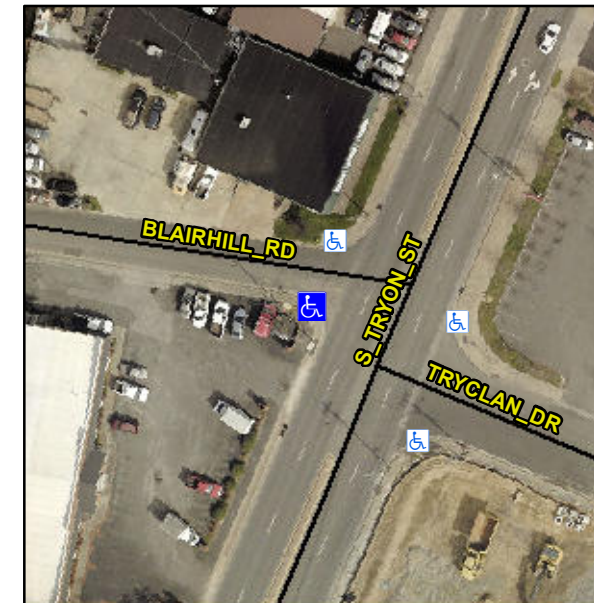
Not Found, R304.5.1, R304.2.2

Compliance	Description	Data	Compliance	Description	Data
N/A	Ramp Length (in)	63.0	No	Ramp Slope (%)	8.7
No	Ramp Width (in)	46.0	Yes	Ramp XSlope (%)	0.5
N/A	Flare Type LT	N/A	N/A	Flare Type RT	N/A
N/A	Flare Slope LT (%)	N/A	N/A	Flare Slope RT (%)	N/A
N/A	Flare Traversable LT?	N/A	N/A	Flare Traversable RT?	N/A
N/A	Landing Length (in)	N/A	N/A	DWS Provided?	N/A
N/A	Landing Width (in)	N/A	N/A	DWS Contrast?	N/A
N/A	Landing Slope (%)	N/A	N/A	DWS Length (in)	N/A
N/A	Landing X Slope (%)	N/A	N/A	DWS Full Width?	N/A
N/A	Landing Curb? (Y/N)	N/A	N/A	DWS Offset (in)	N/A
N/A	Shared Landing?	N/A			
N/A	Gutter Ponding?	N/A	N/A	Gutter Slope (%)	N/A
N/A	Gutter Lip Ht (in)	N/A	N/A	Gutter X Slope (%)	N/A
N/A	Painted X Walk1?	No	N/A	Painted X Walk2?	No
	X Walk 1 Direction	To E		X Walk 2 Direction	To N
N/A	X Walk 1 Width (in)	N/A	N/A	X Walk 2 Width (in)	N/A
	X Walk 1 Slope (%)	0.3		X Walk 2 Slope (%)	4.0
	X Walk 1 X Slope (%)	4.1		X Walk 2 X Slope (%)	2.1

N/A	Ramp inside XWalk1?	N/A	N/A	Ramp inside XWalk2?	N/A
	Road Slope (%)	1.4	N/A	Clear Space?	N/A
	Road X Slope (%)	6.6	N/A	Clear Space to XWalk (in)	N/A
N/A	Any Obstructions?	N/A	N/A	Storm Grate/Utility Hazard?	N/A
	Obstruction Type			Storm Grate/Utility Type	
		N/A			N/A
			Yes	Surface Condition? (G/P)	Good

Possible Solutions:

Remove & Replace Curb Ramp With Two New Directional Ramps or Equivalent.
