Access Compliance Report Public Rights-of-Way (Curb Ramps)

Intersection ID: 44932	Main Street: NATHAN_DR	Cross Street: BRUMIT_LN	Location: NE
ADA ID: 681CFE6DEDF0	Ramp Type: PerpDiag	Initial Pass/Fail: Fail	Overall Compliance: No Severity Score: 10

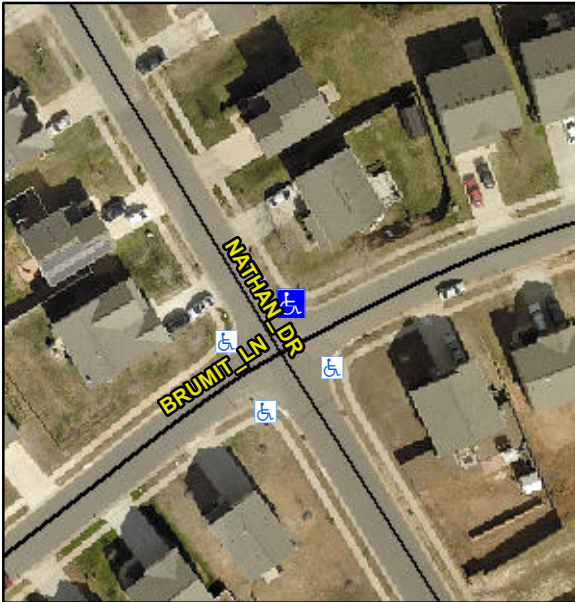
Not Found, R304.5.1, R304.5.3

Compliance	Description	Data	Compliance	Description	Data
N/A	Ramp Length (in)	48.5	Yes	Ramp Slope (%)	6.4
No	Ramp Width (in)	46.0	No	Ramp XSlope (%)	4.5
N/A	Flare Type LT	N/A	N/A	Flare Type RT	N/A
N/A	Flare Slope LT (%)	N/A	N/A	Flare Slope RT (%)	N/A
N/A	Flare Traversable LT?	N/A	N/A	Flare Traversable RT?	N/A
N/A	Landing Length (in)	N/A	N/A	DWS Provided?	N/A
N/A	Landing Width (in)	N/A	N/A	DWS Contrast?	N/A
N/A	Landing Slope (%)	N/A	N/A	DWS Length (in)	N/A
N/A	Landing X Slope (%)	N/A	N/A	DWS Full Width?	N/A
N/A	Landing Curb? (Y/N)	N/A	N/A	DWS Offset (in)	N/A
N/A	Shared Landing?	N/A			
N/A	Gutter Ponding?	N/A	N/A	Gutter Slope (%)	N/A
N/A	Gutter Lip Ht (in)	N/A	N/A	Gutter X Slope (%)	N/A
N/A	Painted X Walk1?	No	N/A	Painted X Walk2?	No
	X Walk 1 Direction	To SE		X Walk 2 Direction	To SW
N/A	X Walk 1 Width (in)	N/A	N/A	X Walk 2 Width (in)	N/A
	X Walk 1 Slope (%)	2.6		X Walk 2 Slope (%)	4.4
	X Walk 1 X Slope (%)	4.2		X Walk 2 X Slope (%)	0.2

N/A	Ramp inside XWalk1?	N/A	N/A	Ramp inside XWalk2?	N/A
	Road Slope (%)	3.2	N/A	Clear Space?	N/A
	Road X Slope (%)	4.3	N/A	Clear Space to XWalk (in)	N/A
N/A	Any Obstructions?	N/A	N/A	Storm Grate/Utility Hazard?	N/A
	Obstruction Type			Storm Grate/Utility Type	
			N/A		N/A
			Yes	Surface Condition? (G/P)	Good

Possible Solutions:

Remove & Replace Curb Ramp With Two New Directional Ramps or Equivalent.
