# Access Compliance Report

## Public Rights-of-Way

### (Curb Ramps)

Intersection ID: 47697	Main Street: NIGHT_HERON_LN	Cross Street: LEES_COURT_ST	Location: E
ADA ID: 681DBBC48EFB	Ramp Type: PerpDiag	Initial Pass/Fail: Fail	Overall Compliance: No
		Severity Score: 10

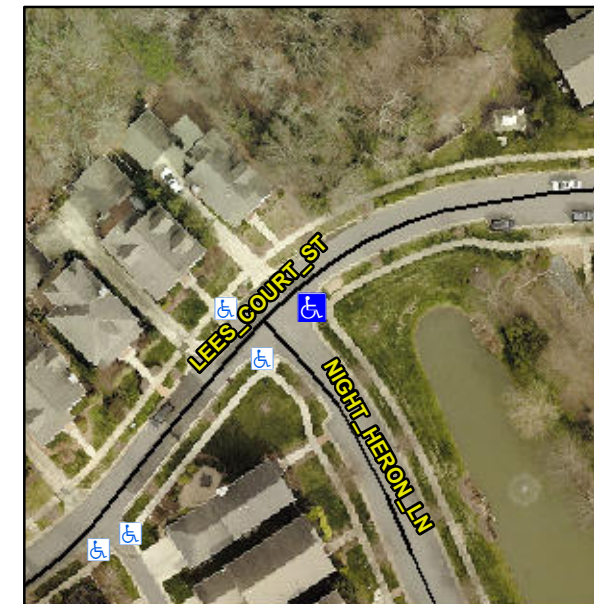
**Not Found, R304.5.1, R304.5.3**

Compliance	Description	Data	Compliance	Description	Data
N/A	Ramp Length (in)	71.0	Yes	Ramp Slope (%)	6.7
No	Ramp Width (in)	44.0	No	Ramp XSlope (%)	3.2
N/A	Flare Type LT	N/A	N/A	Flare Type RT	N/A
N/A	Flare Slope LT (%)	N/A	N/A	Flare Slope RT (%)	N/A
N/A	Flare Traversable LT?	N/A	N/A	Flare Traversable RT?	N/A
N/A	Landing Length (in)	N/A	N/A	DWS Provided?	N/A
N/A	Landing Width (in)	N/A	N/A	DWS Contrast?	N/A
N/A	Landing Slope (%)	N/A	N/A	DWS Length (in)	N/A
N/A	Landing X Slope (%)	N/A	N/A	DWS Full Width?	N/A
N/A	Landing Curb? (Y/N)	N/A	N/A	DWS Offset (in)	N/A
N/A	Shared Landing?	N/A			
N/A	Gutter Ponding?	N/A	N/A	Gutter Slope (%)	N/A
N/A	Gutter Lip Ht (in)	N/A	N/A	Gutter X Slope (%)	N/A
N/A	Painted X Walk1?	No	N/A	Painted X Walk2?	No
	X Walk 1 Direction	To NW		X Walk 2 Direction	To SW
N/A	X Walk 1 Width (in)	N/A	N/A	X Walk 2 Width (in)	N/A
	X Walk 1 Slope (%)	1.8		X Walk 2 Slope (%)	0.5
	X Walk 1 X Slope (%)	0.5		X Walk 2 X Slope (%)	2.6

N/A	Ramp inside XWalk1?	N/A	N/A	Ramp inside XWalk2?	N/A
	Road Slope (%)	0.9	N/A	Clear Space?	N/A
	Road X Slope (%)	2.5	N/A	Clear Space to XWalk (in)	N/A
N/A	Any Obstructions?	N/A	N/A	Storm Grate/Utility Hazard?	N/A
	Obstruction Type			Storm Grate/Utility Type	
		N/A			N/A
			Yes	Surface Condition? (G/P)	Good

**Remove & Replace Curb Ramp With Two New Directional Ramps or Equivalent.**
