# Access Compliance Report

## Public Rights-of-Way

### (Curb Ramps)

| Intersection ID: 9298 | Main Street: BARRYMORE_DR | Cross Street: CLINTWOOD_DR | Location: NW |

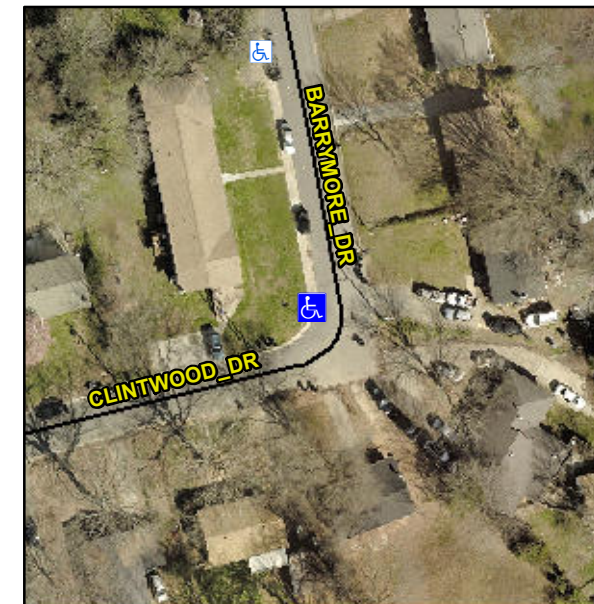
**Not Found, R304.2.1, R304.2.2-Perp, R304.3.2-Para**

| Compliance | Description | Data | Compliance | Description | Data |
|---|---|---|---|---|---|
| No | Landing Length (in) | 24.0 | Yes | DWS Provided? | Yes |
| No | Landing Width (in) | 47.0 | Yes | DWS Contrast? | Yes |
| No | Landing Slope (%) | 3.2 | Yes | DWS Length (in) | 24.5 |

**Remove & Replace Curb Ramp With Two New Directional Ramps or Equivalent.**

Total Cost: \$ 3200.00
