Access Compliance Report

Public Rights-of-Way

(Curb Ramps)

Intersection ID: 48001	Main Street: LARKMEAD_FOREST_DR	Cross Street: CLYMER_CT	Location:	NW
ADA ID: 682C65318CEA	Ramp Type: Perp	Initial Pass/Fail: Fail	Overall Compliance: No	Severity Score: 22.5

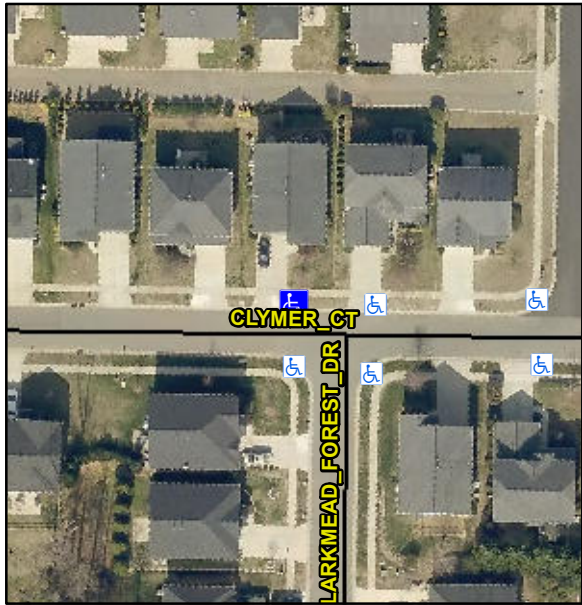
Possible Solutions:		Remove & Replace Entire Ramp.					
	Surveyor Notes:		N/A					
	PROW/ADA:		Not Found, R304.5.1, R304.2.2, R304.5.3					
	Total Cost:		\$ 1850.00					
	Street 1 Name		CLYMER CT					
	Stop Condition-Street 2		None					
	Street 2 Name		N/A					
	Stop Condition-Street 1		N/A					
			Compliance	Description	Data	Compliance	Description	Data
			N/A	Ramp Length (in)	71.5	No	Ramp Slope (%)	9.8
			No	Ramp Width (in)	46.0	No	Ramp XSlope (%)	3.1
			N/A	Flare Type LT	N/A	N/A	Flare Type RT	N/A
			N/A	Flare Slope LT (%)	N/A	N/A	Flare Slope RT (%)	N/A
			N/A	Flare Traversable LT?	N/A	N/A	Flare Traversable RT?	N/A
			N/A	Landing Length (in)	N/A	N/A	DWS Provided?	N/A
			N/A	Landing Width (in)	N/A	N/A	DWS Contrast?	N/A
			N/A	Landing Slope (%)	N/A	N/A	DWS Length (in)	N/A
			N/A	Landing X Slope (%)	N/A	N/A	DWS Full Width?	N/A
