Access Compliance Report Public Rights-of-Way (Curb Ramps)

Intersection ID: 4649 Main Street: BLUE_ASTER_LN **Cross Street: CHASEWIND_DR** Location: Ε **Overall Compliance: No** ADA ID: 682F5C6433D0 Ramp Type: Perp Initial Pass/Fail: Fail **Severity Score:** 12.5

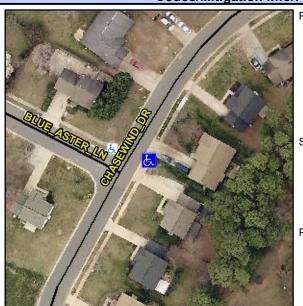
Field Measurements/Component Compliance								
Comp	liance Description	Data	Comp	liance	Description	Data		
N/A	Ramp Length (in)	47.0	No	Ramp	Slope (%)	9.0		
Yes	Ramp Width (in)	50.0	Yes	Ramp	XSlope (%)	0.5		
N/A	Flare Type LT	N/A	N/A	Flare	Type RT	N/A		
N/A	Flare Slope LT (%)	N/A	N/A	Flare	Slope RT (%)	N/A		
N/A	Flare Traversable LT?	N/A	N/A	Flare	Traversable RT?	N/A		
N/A	Landing Length (in)	N/A	N/A	DWS	Provided?	N/A		
N/A	Landing Width (in)	N/A	N/A	DWS	Contrast?	N/A		
N/A	Landing Slope (%)	N/A	N/A	DWS	Length (in)	N/A		
N/A	Landing X Slope (%)	N/A	N/A	DWS	Full Width?	N/A		
N/A	Landing Curb? (Y/N)	N/A	N/A	DWS	Offset (in)	N/A		
N/A	Shared Landing?	N/A						
N/A	Gutter Ponding?	N/A	N/A	Gutte	r Slope (%)	N/A		
N/A	Gutter Lip Ht (in)	N/A	N/A	Gutte	r X Slope (%)	N/A		
N/A	Painted X Walk1?	No	N/A	Paint	ed X Walk2?	N/A		
	X Walk 1 Direction	To NW		X Wa	lk 2 Direction	N/A		
N/A	X Walk 1 Width (in)	N/A	N/A	X Wa	lk 2 Width (in)	N/A

X Walk 1 Slope (%)	2.8		X Wa	lk 2 Slope (%)	N/A		
	X Walk 1 X Slope (%)	3.0		X Wa	lk 2 X Slope (%)	N/A		
N/A	Ramp inside XWalk1?	N/A	N/A	Ram	inside XWalk2?	N/A		
	Road Slope (%)	N/A	N/A	Clear	Space?	N/A		
	Road X Slope (%)	N/A	N/A	Clear	Space to XWalk (in)	N/A		
N/A	Any Obstructions?	N/A	N/A	Storn	n Grate/Utility Hazard?	N/A		
	Obstruction Type			Storn	n Grate/Utility Type			
		N/A				N/A		
			Yes	Surfa	ce Condition? (G/P)	Good

•	
Possible Solutions:	<u>C</u>
Remove & Replace Entire Ramp.	N/
	Ye
	N/
	N/
	N/
	N/
Surveyor Notes:	N/
N/A	N/
	N/
	N/
	N/
PROW/ADA:	N/
Not Found, R304.2.2	N/
, , , , , , , , , , , , , , , , , , , ,	N/
	N/
	N/
