Access Compliance Report

Public Rights-of-Way

(Curb Ramps)

Intersection ID: 15905	Main Street: PEMBROKE_AV	Cross Street: QUEENS_RD	Location: NW
ADA ID: 682FA0B66CB9	Ramp Type: Perp	Initial Pass/Fail: Fail	Overall Compliance: No
Severity Score: 10			
Codes/Mitigation Info/Possible Solution		Field Measurements/Component Compliance

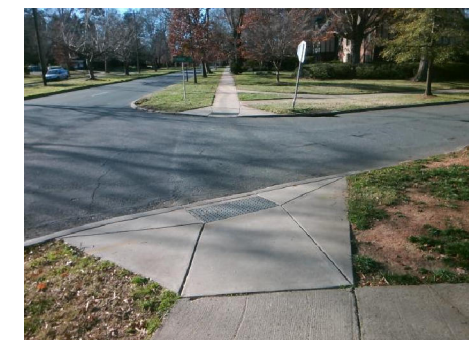
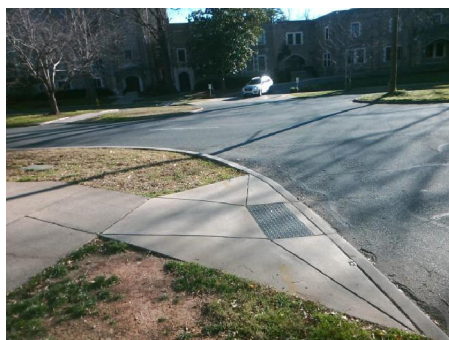
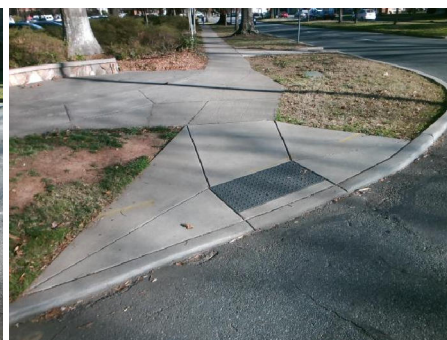
Not Found, R304.5.1, R304.5.3

Compliance	Description	Data	Compliance	Description	Data
N/A	Ramp Length (in)	99.0	Yes	Ramp Slope (%)	7.5
No	Ramp Width (in)	46.0	No	Ramp XSlope (%)	3.1
N/A	Flare Type LT	N/A	N/A	Flare Type RT	N/A
N/A	Flare Slope LT (%)	N/A	N/A	Flare Slope RT (%)	N/A
N/A	Flare Traversable LT?	N/A	N/A	Flare Traversable RT?	N/A
N/A	Landing Length (in)	N/A	N/A	DWS Provided?	N/A
N/A	Landing Width (in)	N/A	N/A	DWS Contrast?	N/A
N/A	Landing Slope (%)	N/A	N/A	DWS Length (in)	N/A
N/A	Landing X Slope (%)	N/A	N/A	DWS Full Width?	N/A
N/A	Landing Curb? (Y/N)	N/A	N/A	DWS Offset (in)	N/A
N/A	Shared Landing?	N/A			
N/A	Gutter Ponding?	N/A	N/A	Gutter Slope (%)	N/A
N/A	Gutter Lip Ht (in)	N/A	N/A	Gutter X Slope (%)	N/A
N/A	Painted X Walk1?	No	N/A	Painted X Walk2?	N/A
	X Walk 1 Direction	To SW		X Walk 2 Direction	N/A
N/A	X Walk 1 Width (in)	N/A	N/A	X Walk 2 Width (in)	N/A
	X Walk 1 Slope (%)	3.0		X Walk 2 Slope (%)	N/A
	X Walk 1 X Slope (%)	3.7		X Walk 2 X Slope (%)	N/A

N/A	Ramp inside XWalk1?	N/A	N/A	Ramp inside XWalk2?	N/A
	Road Slope (%)	N/A	N/A	Clear Space?	N/A
	Road X Slope (%)	N/A	N/A	Clear Space to XWalk (in)	N/A
N/A	Any Obstructions?	N/A	N/A	Storm Grate/Utility Hazard?	N/A
	Obstruction Type			Storm Grate/Utility Type	
		N/A			N/A
			Yes	Surface Condition? (G/P)	Good

Possible Solutions:

Remove & Replace Entire Ramp.

Total Cost: \$ 1850.00
