Access Compliance Report

Public Rights-of-Way (Curb Ramps)

Intersection ID: 10032958	Main Street: NEW RENAISSANCE_WY	Cross Street: N/A	Location: NW
ADA ID: 6836844B8270	Ramp Type: Directional1	Initial Pass/Fail: Fail	Overall Compliance: No
Codes/Mitigation Info/Possible Solution		Field Measurements/Component Compliance	
Severity Score: 1.25

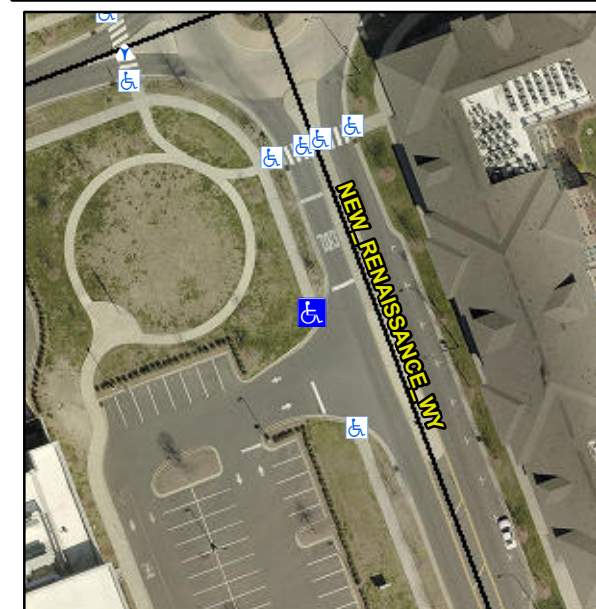
Compliance	Description	Data	Compliance	Description	Data
N/A	Ramp Length (in)	48.0	N/A	Grade Break?	N/A
Yes	Ramp Width (in)	72.0	N/A	Grade Break Slope (%)	0.0
Yes	Ramp Slope (%)	0.3	N/A	Grade Break XSlope (%)	0.0
No	Ramp XSlope (%)	2.3			
N/A	Flare Type LT	N/A	N/A	Flare Type RT	N/A
N/A	Flare Slope LT (%)	N/A	N/A	Flare Slope RT (%)	0.0
N/A	Flare Traversable LT?	N/A	N/A	Flare Traversable RT?	N/A
N/A	Landing Length (in)	0.0	N/A	DWS Provided?	N/A
N/A	Landing Width (in)	0.0	N/A	DWS Contrast?	N/A
N/A	Landing Slope (%)	0.0	N/A	DWS Length (in)	N/A
N/A	Landing X Slope (%)	0.0	N/A	DWS Full Width?	N/A
N/A	Landing Curb? (Y/N)	N/A	N/A	DWS Offset LT (in)	N/A
N/A	Shared Landing?	N/A	N/A	DWS Offset RT (in)	N/A
N/A	Gutter Ponding?	0.0	N/A	Gutter Slope (%)	N/A
N/A	Gutter Lip Ht (in)	0.0	N/A	Gutter X Slope (%)	N/A
N/A	Painted X Walk1?	No		Road Slope (%)	1.0
	X Walk 1 Direction	To SE		Road X Slope (%)	3.5
	X Walk 1 Width (in)	N/A		Clear Space?	N/A

X Walk 1 Slope (%)	1.0	N/A	Clear Space to XWalk (in)	N/A
	X Walk 1 X Slope (%)	3.5	N/A	Storm Grate/Utility Hazard?	N/A
N/A	Ramp inside XWalk1?	N/A		Storm Grate/Utility Type	
N/A	Any Obstructions?	N/A			N/A
	Obstruction Type		Yes	Surface Condition? (G/P)	Good
			N/A	Curb Slope (%)	3.2

Possible Solutions:

Remove & Replace Entire Ramp.

R304.5.3
