Access Compliance Report

Public Rights-of-Way

(Curb Ramps)

Intersection ID: 11783	Main Street: N_GRAHAM_ST	Cross Street: W_5TH_ST	Location: S
ADA ID: 68380169B63D	Ramp Type: Perp	Initial Pass/Fail: Fail	Overall Compliance: No
		Severity Score: 12.5

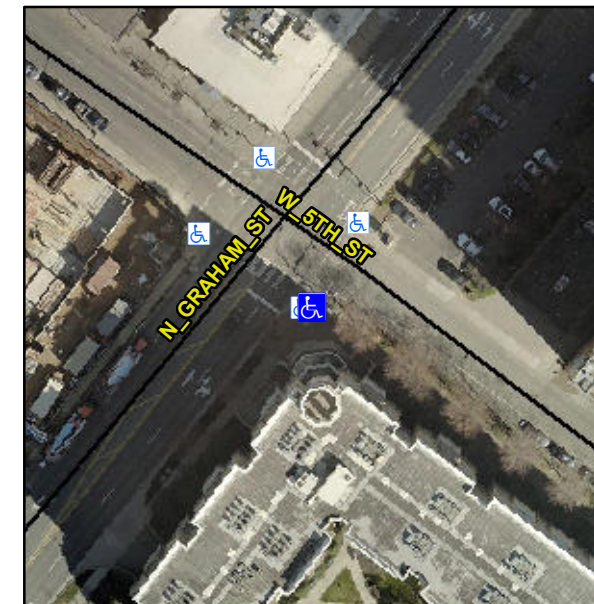
Compliance	Description	Data	Compliance	Description	Data
N/A	Ramp Length (in)	84.0	No	Ramp Slope (%)	11.0
Yes	Ramp Width (in)	48.0	Yes	Ramp XSlope (%)	0.2
N/A	Flare Type LT	N/A	N/A	Flare Type RT	N/A
N/A	Flare Slope LT (%)	N/A	N/A	Flare Slope RT (%)	N/A
N/A	Flare Traversable LT?	N/A	N/A	Flare Traversable RT?	N/A
N/A	Landing Length (in)	N/A	N/A	DWS Provided?	N/A
N/A	Landing Width (in)	N/A	N/A	DWS Contrast?	N/A
N/A	Landing Slope (%)	N/A	N/A	DWS Length (in)	N/A
N/A	Landing X Slope (%)	N/A	N/A	DWS Full Width?	N/A
N/A	Landing Curb? (Y/N)	N/A	N/A	DWS Offset (in)	N/A
N/A	Shared Landing?	N/A			
N/A	Gutter Ponding?	N/A	N/A	Gutter Slope (%)	N/A
N/A	Gutter Lip Ht (in)	N/A	N/A	Gutter X Slope (%)	N/A
N/A	Painted X Walk1?	Yes	N/A	Painted X Walk2?	N/A
	X Walk 1 Direction	To NE		X Walk 2 Direction	N/A
N/A	X Walk 1 Width (in)	110.0	N/A	X Walk 2 Width (in)	N/A
	X Walk 1 Slope (%)	0.7		X Walk 2 Slope (%)	N/A
	X Walk 1 X Slope (%)	0.8		X Walk 2 X Slope (%)	N/A

N/A	Ramp inside XWalk1?	Yes	N/A	Ramp inside XWalk2?	N/A
	Road Slope (%)	N/A	N/A	Clear Space?	N/A
	Road X Slope (%)	N/A	N/A	Clear Space to XWalk (in)	N/A
N/A	Any Obstructions?	N/A	N/A	Storm Grate/Utility Hazard?	N/A
	Obstruction Type			Storm Grate/Utility Type	
		N/A			N/A
			Yes	Surface Condition? (G/P)	Good

Possible Solutions:

Remove & Replace Entire Ramp.

R304.2.2
