# Access Compliance Report

## Public Rights-of-Way

### (Curb Ramps)

Intersection ID: N/A	Main Street: CALAWOOD_WY	Cross Street: BECKSTONE_WY	Location: SE
ADA ID: 6845ADFD6C7B	Ramp Type: BlendTrans1	Initial Pass/Fail: Fail	Overall Compliance: No
		Severity Score: 1.25

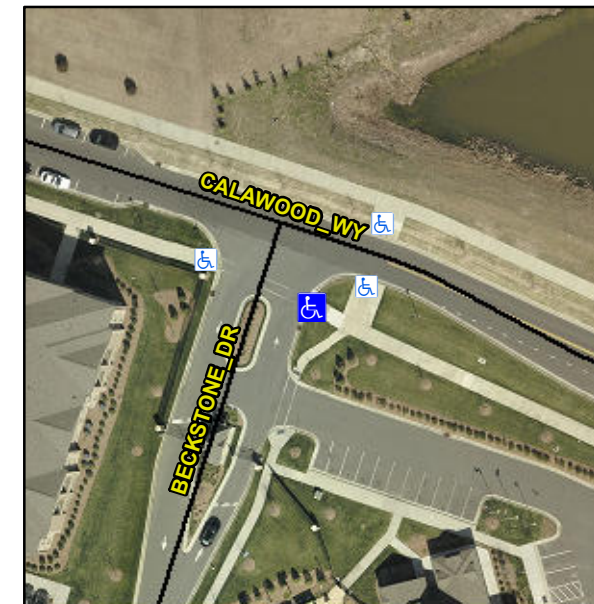
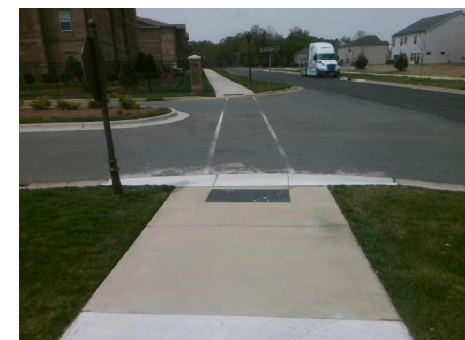
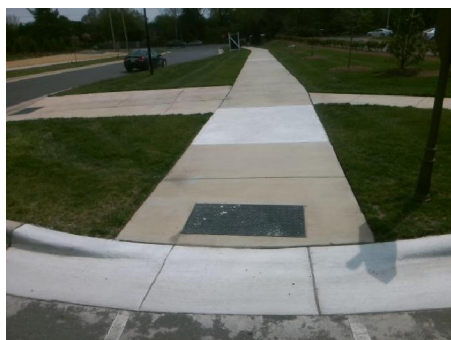
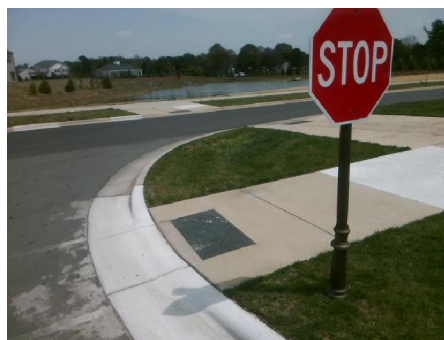
Compliance	Description	Data	Compliance	Description	Data
N/A	Ramp Length (in)	61.0	Yes	BlendTrans Slope (%)	3.5
Yes	Ramp Width (in)	48.0	No	BlendTrans XSlope (%)	2.3
N/A	Flare Type LT	N/A	N/A	Flare Type RT	N/A
N/A	Flare Slope LT (%)	N/A	N/A	Flare Slope RT (%)	N/A
N/A	Flare Traversable LT?	N/A	N/A	Flare Traversable RT?	N/A
N/A	Landing Length (in)	N/A	N/A	DWS Provided?	N/A
N/A	Landing Width (in)	N/A	N/A	DWS Contrast?	N/A
N/A	Landing Slope (%)	N/A	N/A	DWS Length (in)	N/A
N/A	Landing X Slope (%)	N/A	N/A	DWS Full Width?	N/A
N/A	Landing Curb? (Y/N)	N/A	N/A	DWS Offset (in)	N/A
N/A	Shared Landing?	N/A			
N/A	Gutter Ponding?	N/A	N/A	Gutter Slope (%)	N/A
N/A	Gutter Lip Ht (in)	N/A	N/A	Gutter X Slope (%)	N/A
N/A	Painted X Walk1?	Yes	N/A	Painted X Walk2?	N/A
	X Walk 1 Direction	To NW		X Walk 2 Direction	N/A
	X Walk 1 Width (in)	59.0		X Walk 2 Width (in)	N/A
	X Walk 1 Slope (%)	2.8		X Walk 2 Slope (%)	N/A
	X Walk 1 X Slope (%)	1.3		X Walk 2 X Slope (%)	N/A

N/A	Ramp inside XWalk1?	Yes	N/A	Ramp inside XWalk2?	N/A
	Road Slope (%)	1.3		Clear Space?	N/A
	Road X Slope (%)	2.8	N/A	Clear Space to XWalk (in)	N/A
N/A	Any Obstructions?	N/A	N/A	Storm Grate/Utility Hazard?	N/A
	Obstruction Type			Storm Grate/Utility Type	
		N/A			N/A
			Yes	Surface Condition? (G/P)	Good
			N/A	Curb Slope (%)	1.3

**Remove & Replace Curb Ramp With Two New Directional Ramps or Equivalent.**

**R304.5.3**
