# Access Compliance Report

## Public Rights-of-Way

### (Curb Ramps)

Intersection ID: 2666	Main Street: FAIRVISTA_DR	Cross Street: SUNBEAM_LN	Location: W
ADA ID: 6847546C0780	Ramp Type: PerpDiag	Initial Pass/Fail: Fail	Overall Compliance: No
			Severity Score: 21.25

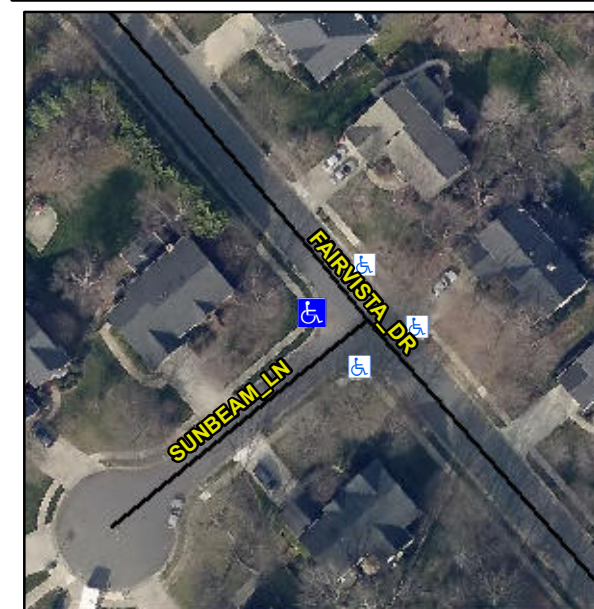
**Not Found, R304.5.1, R304.2.2**

Compliance	Description	Data	Compliance	Description	Data
N/A	Ramp Length (in)	46.0	No	Ramp Slope (%)	11.2
No	Ramp Width (in)	38.0	Yes	Ramp XSlope (%)	0.7
N/A	Flare Type LT	N/A	N/A	Flare Type RT	N/A
N/A	Flare Slope LT (%)	N/A	N/A	Flare Slope RT (%)	N/A
N/A	Flare Traversable LT?	N/A	N/A	Flare Traversable RT?	N/A
N/A	Landing Length (in)	N/A	N/A	DWS Provided?	N/A
N/A	Landing Width (in)	N/A	N/A	DWS Contrast?	N/A
N/A	Landing Slope (%)	N/A	N/A	DWS Length (in)	N/A
N/A	Landing X Slope (%)	N/A	N/A	DWS Full Width?	N/A
N/A	Landing Curb? (Y/N)	N/A	N/A	DWS Offset (in)	N/A
N/A	Shared Landing?	N/A			
N/A	Gutter Ponding?	N/A	N/A	Gutter Slope (%)	N/A
N/A	Gutter Lip Ht (in)	N/A	N/A	Gutter X Slope (%)	N/A
N/A	Painted X Walk1?	No	N/A	Painted X Walk2?	No
	X Walk 1 Direction	To SE		X Walk 2 Direction	To NE
N/A	X Walk 1 Width (in)	N/A	N/A	X Walk 2 Width (in)	N/A
	X Walk 1 Slope (%)	0.1		X Walk 2 Slope (%)	2.4
	X Walk 1 X Slope (%)	0.6		X Walk 2 X Slope (%)	2.5

**Remove & Replace Curb Ramp With Two New Directional Ramps or Equivalent.**
