# Access Compliance Report

## Public Rights-of-Way

### (Curb Ramps)

| Intersection ID: 10503 | Main Street: N_GRAHAM_ST | Cross Street: PLYMOUTH_AV | Location: E |

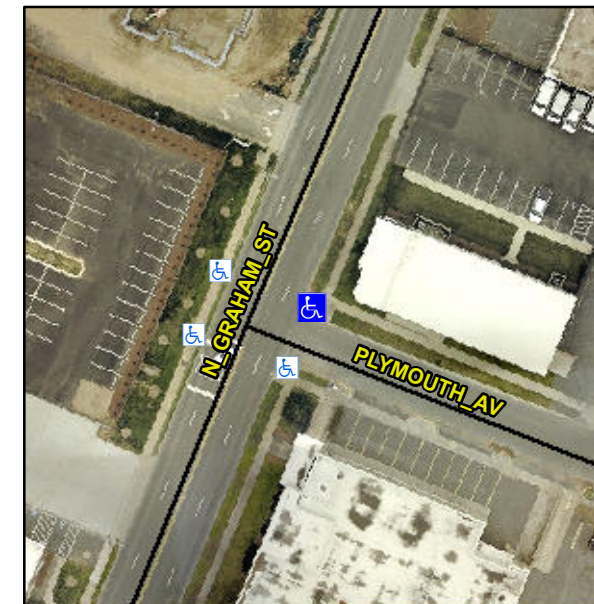
| ADA ID: 68542448A4B0 | Ramp Type: PerpDiag | Initial Pass/Fail: Pass | Overall Compliance: No |
| Severity Score: 17.75 | | | |

**R304.5.3, R304.2.1, R305.1.4, R305.2, R302.7, R302.7.2**

| Compliance | Description | Data | Compliance | Description | Data |
|---|---|---|---|---|---|
| Yes | Ramp Width (in) | 48.0 | No | Ramp XSlope (%) | 4.4 |
| No | Landing Width (in) | 39.0 | Yes | DWS Contrast? | Yes |
| Yes | Landing X Slope (%) | 1.0 | No | DWS Full Width? | No |
| N/A | Landing Curb? (Y/N) | No | No | DWS Offset (in) | 5.0 |
| No | Gutter Ponding? | Yes | Yes | Gutter Slope (%) | 3.0 |
| No | Gutter Lip Ht (in) | 1.0 | Yes | Gutter X Slope (%) | 0.7 |

**Remove & Replace Curb Ramp With Two New Directional Ramps or Equivalent. Grind Gutter Lip.**

Total Cost: \$ 3400.00

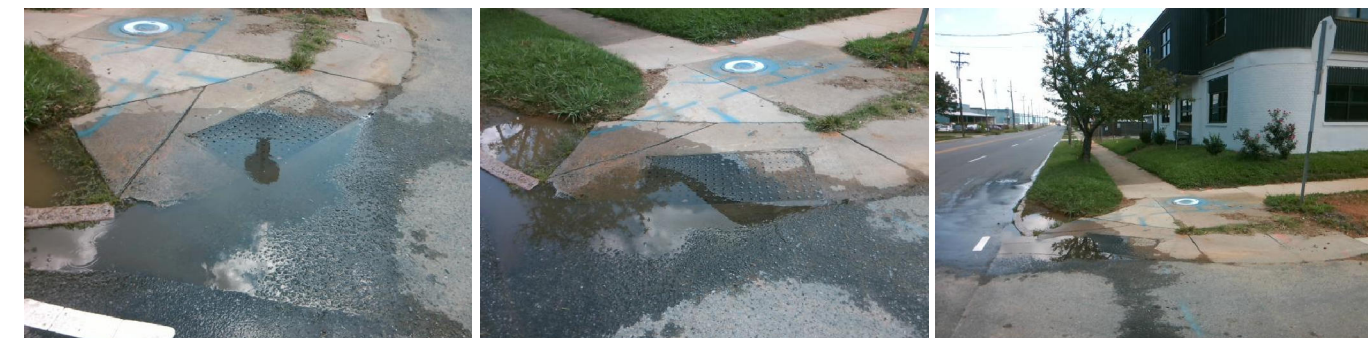
| Compliance | Description | Data | Compliance | Description | Data |
|---|---|---|---|---|---|
| N/A | Ramp Length (in) | 45.0 | Yes | Ramp Slope (%) | 6.0 |
