Access Compliance Report

Public Rights-of-Way

(Curb Ramps)

Intersection ID: 50636	Main Street: BLUE_GROVE_RD	Cross Street: RED_WATER_RD	Location: NW
ADA ID: 68542BCE59C2	Ramp Type: Perp	Initial Pass/Fail: Fail	Overall Compliance: No
Severity Score: 13.75			
Codes/Mitigation Info/Possible Solution		Field Measurements/Component Compliance

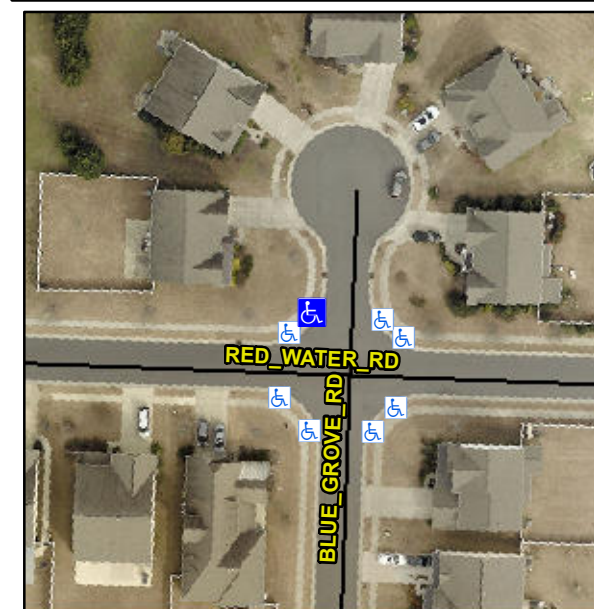
Not Found, R304.2.2, R304.5.3

Compliance	Description	Data	Compliance	Description	Data
N/A	Ramp Length (in)	47.0	No	Ramp Slope (%)	8.8
Yes	Ramp Width (in)	48.0	No	Ramp XSlope (%)	3.2
N/A	Flare Type LT	N/A	N/A	Flare Type RT	N/A
N/A	Flare Slope LT (%)	N/A	N/A	Flare Slope RT (%)	N/A
N/A	Flare Traversable LT?	N/A	N/A	Flare Traversable RT?	N/A
N/A	Landing Length (in)	N/A	N/A	DWS Provided?	N/A
N/A	Landing Width (in)	N/A	N/A	DWS Contrast?	N/A
N/A	Landing Slope (%)	N/A	N/A	DWS Length (in)	N/A
N/A	Landing X Slope (%)	N/A	N/A	DWS Full Width?	N/A
N/A	Landing Curb? (Y/N)	N/A	N/A	DWS Offset (in)	N/A
N/A	Shared Landing?	N/A			
N/A	Gutter Ponding?	N/A	N/A	Gutter Slope (%)	N/A
N/A	Gutter Lip Ht (in)	N/A	N/A	Gutter X Slope (%)	N/A
N/A	Painted X Walk1?	No	N/A	Painted X Walk2?	N/A
	X Walk 1 Direction	To SE		X Walk 2 Direction	N/A
N/A	X Walk 1 Width (in)	N/A	N/A	X Walk 2 Width (in)	N/A
	X Walk 1 Slope (%)	1.8		X Walk 2 Slope (%)	N/A
	X Walk 1 X Slope (%)	3.0		X Walk 2 X Slope (%)	N/A

N/A	Ramp inside XWalk1?	N/A	N/A	Ramp inside XWalk2?	N/A
	Road Slope (%)	N/A	N/A	Clear Space?	N/A
	Road X Slope (%)	N/A	N/A	Clear Space to XWalk (in)	N/A
N/A	Any Obstructions?	N/A	N/A	Storm Grate/Utility Hazard?	N/A
	Obstruction Type			Storm Grate/Utility Type	
		N/A			N/A
			Yes	Surface Condition? (G/P)	Good

Remove & Replace Entire Ramp.

Total Cost: \$ 1850.00
