Access Compliance Report

Public Rights-of-Way

(Curb Ramps)

Intersection ID: 14360	Main Street: BALDWIN_AV	Cross Street: MAIN_ST	Location: W
ADA ID: 6856AFC4D6E0	Ramp Type: Perp	Initial Pass/Fail: Fail	Overall Compliance: No
Severity Score: 12.5			
Codes/Mitigation Info/Possible Solution		Field Measurements/Component Compliance

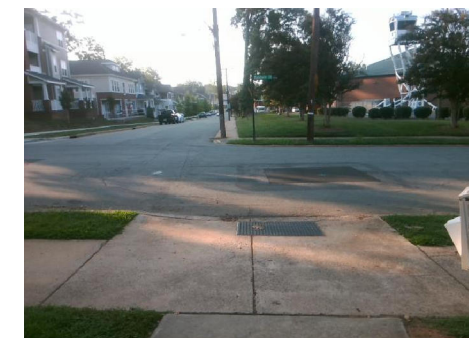
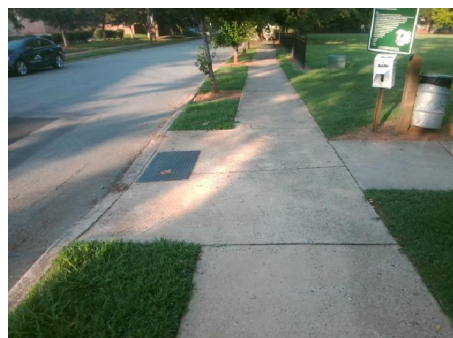
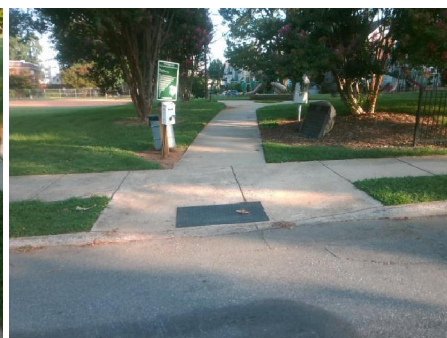
Compliance	Description	Data	Compliance	Description	Data
N/A	Ramp Length (in)	100.0	Yes	Ramp Slope (%)	6.4
Yes	Ramp Width (in)	48.0	No	Ramp XSlope (%)	5.6
N/A	Flare Type LT	N/A	N/A	Flare Type RT	N/A
N/A	Flare Slope LT (%)	N/A	N/A	Flare Slope RT (%)	N/A
N/A	Flare Traversable LT?	N/A	N/A	Flare Traversable RT?	N/A
N/A	Landing Length (in)	N/A	N/A	DWS Provided?	N/A
N/A	Landing Width (in)	N/A	N/A	DWS Contrast?	N/A
N/A	Landing Slope (%)	N/A	N/A	DWS Length (in)	N/A
N/A	Landing X Slope (%)	N/A	N/A	DWS Full Width?	N/A
N/A	Landing Curb? (Y/N)	N/A	N/A	DWS Offset (in)	N/A
N/A	Shared Landing?	N/A			
N/A	Gutter Ponding?	N/A	N/A	Gutter Slope (%)	N/A
N/A	Gutter Lip Ht (in)	N/A	N/A	Gutter X Slope (%)	N/A
N/A	Painted X Walk1?	No	N/A	Painted X Walk2?	N/A
	X Walk 1 Direction	To SE		X Walk 2 Direction	N/A
N/A	X Walk 1 Width (in)	N/A	N/A	X Walk 2 Width (in)	N/A
	X Walk 1 Slope (%)	2.3		X Walk 2 Slope (%)	N/A
	X Walk 1 X Slope (%)	3.1		X Walk 2 X Slope (%)	N/A

N/A	Ramp inside XWalk1?	N/A	N/A	Ramp inside XWalk2?	N/A
	Road Slope (%)	N/A	N/A	Clear Space?	N/A
	Road X Slope (%)	N/A	N/A	Clear Space to XWalk (in)	N/A
N/A	Any Obstructions?	N/A	N/A	Storm Grate/Utility Hazard?	N/A
	Obstruction Type			Storm Grate/Utility Type	
		N/A			N/A
			Yes	Surface Condition? (G/P)	Good

Possible Solutions:

Remove & Replace Entire Ramp.

R304.5.3
