Access Compliance Report

Public Rights-of-Way

(Curb Ramps)

Intersection ID: 29970	Main Street: BROAD RIDGE CT	Cross Street: CANIPE DR	Location: S
ADA ID: 6859FE26E869	Ramp Type: PerpDiag	Initial Pass/Fail: Fail	Overall Compliance: No
Severity Score: 10			
Codes/Mitigation Info/Possible Solution		Field Measurements/Component Compliance

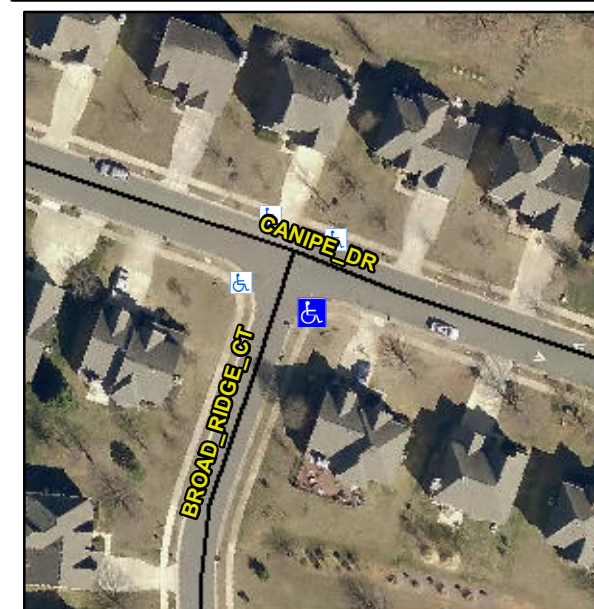
R304.5.1, R304.5.3

Compliance	Description	Data	Compliance	Description	Data
N/A	Ramp Length (in)	50.0	Yes	Ramp Slope (%)	6.9
No	Ramp Width (in)	37.0	No	Ramp XSlope (%)	2.9
N/A	Flare Type LT	N/A	N/A	Flare Type RT	N/A
N/A	Flare Slope LT (%)	N/A	N/A	Flare Slope RT (%)	N/A
N/A	Flare Traversable LT?	N/A	N/A	Flare Traversable RT?	N/A
N/A	Landing Length (in)	N/A	N/A	DWS Provided?	N/A
N/A	Landing Width (in)	N/A	N/A	DWS Contrast?	N/A
N/A	Landing Slope (%)	N/A	N/A	DWS Length (in)	N/A
N/A	Landing X Slope (%)	N/A	N/A	DWS Full Width?	N/A
N/A	Landing Curb? (Y/N)	N/A	N/A	DWS Offset (in)	N/A
N/A	Shared Landing?	N/A			
N/A	Gutter Ponding?	N/A	N/A	Gutter Slope (%)	N/A
N/A	Gutter Lip Ht (in)	N/A	N/A	Gutter X Slope (%)	N/A
N/A	Painted X Walk1?	No	N/A	Painted X Walk2?	No
	X Walk 1 Direction	To N		X Walk 2 Direction	To W
N/A	X Walk 1 Width (in)	N/A	N/A	X Walk 2 Width (in)	N/A
	X Walk 1 Slope (%)	0.5		X Walk 2 Slope (%)	0.4
	X Walk 1 X Slope (%)	7.0		X Walk 2 X Slope (%)	6.5

N/A	Ramp inside XWalk1?	N/A	N/A	Ramp inside XWalk2?	N/A
	Road Slope (%)	5.2	N/A	Clear Space?	N/A
	Road X Slope (%)	2.9	N/A	Clear Space to XWalk (in)	N/A
N/A	Any Obstructions?	N/A	N/A	Storm Grate/Utility Hazard?	N/A
	Obstruction Type			Storm Grate/Utility Type	
		N/A			N/A
			Yes	Surface Condition? (G/P)	Good

Possible Solutions:

Remove & Replace Curb Ramp With Two New Directional Ramps or Equivalent.
