# Access Compliance Report

## Public Rights-of-Way

| Intersection ID: 42476 | Main Street: SIR_CHARLES_PL | Cross Street: HARRISON_STEEL_DR | Location: W |
| ADA ID: 685A1C195397 | Ramp Type: PerpDiag | Initial Pass/Fail: Fail | Overall Compliance: No |

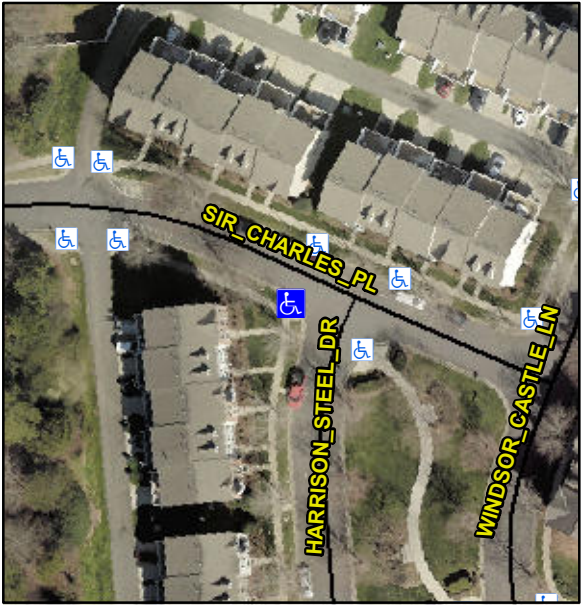
| Codes/Mitigation Info/Possible Solution | | | Field Measurements/Component Compliance | | |
|---|---|--|---|---|---|
| | <b>Remove &amp; Replace Curb Ramp With Two New Directional Ramps or Equivalent.</b> | | <b>No</b> | Ramp Length (in) | 73.0 |
| | | | <b>No</b> | Ramp Width (in) | 29.5 |
| <p>Surveyor Notes:</p> <p><b>N/A</b></p> <p>PROW/ADA:</p> <p><b>R304.5.1, R304.2.2</b></p> | | | <b>N/A</b> | Flare Type RT | N/A |

| Codes/Mitigation Info/Possible Solution | | | Field Measurements/Component Compliance | | |
|---|---|--|---|---|---|
| <p>Total Cost:</p> <p><b>\$ 3200.00</b></p> | | | <b>N/A</b> | | <b>N/A</b> |
