Access Compliance Report

Public Rights-of-Way

(Curb Ramps)

Intersection ID: N/A	Main Street: GANNON_DR	Cross Street: RACHEL_FREEMAN_WY	Location: NW
ADA ID: 6861AAC951B7	Ramp Type: Perp	Initial Pass/Fail: Fail	Overall Compliance: No
Severity Score: 1.25			
Codes/Mitigation Info/Possible Solution		Field Measurements/Component Compliance

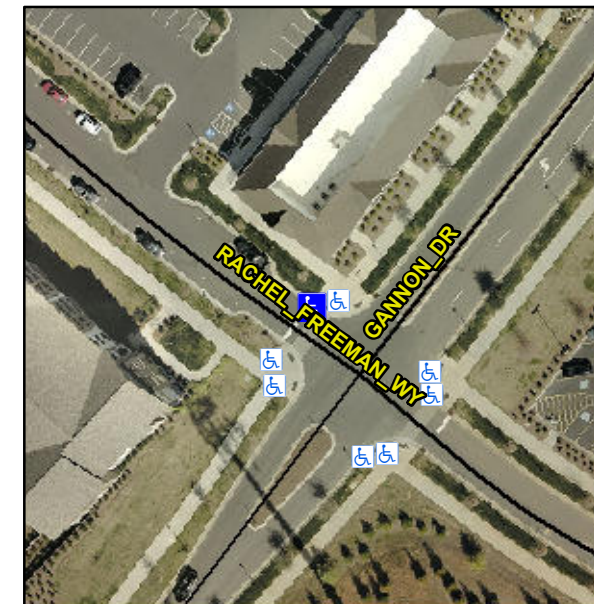
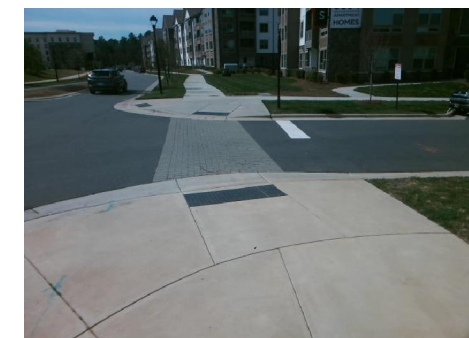
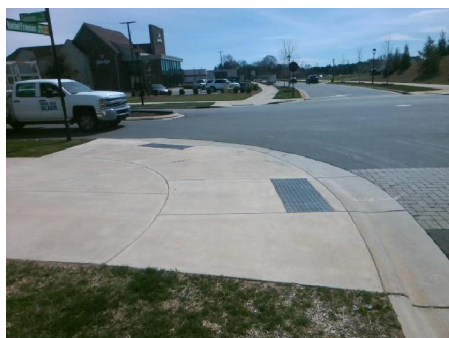
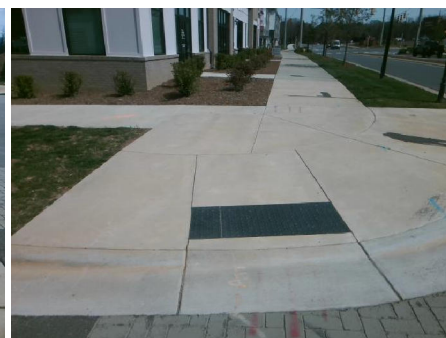
Not Found, R304.5.3

Compliance	Description	Data	Compliance	Description	Data
N/A	Ramp Length (in)	94.0	Yes	Ramp Slope (%)	5.9
Yes	Ramp Width (in)	60.0	No	Ramp XSlope (%)	5.0
N/A	Flare Type LT	N/A	N/A	Flare Type RT	N/A
N/A	Flare Slope LT (%)	N/A	N/A	Flare Slope RT (%)	N/A
N/A	Flare Traversable LT?	N/A	N/A	Flare Traversable RT?	N/A
N/A	Landing Length (in)	N/A	N/A	DWS Provided?	N/A
N/A	Landing Width (in)	N/A	N/A	DWS Contrast?	N/A
N/A	Landing Slope (%)	N/A	N/A	DWS Length (in)	N/A
N/A	Landing X Slope (%)	N/A	N/A	DWS Full Width?	N/A
N/A	Landing Curb? (Y/N)	N/A	N/A	DWS Offset (in)	N/A
N/A	Shared Landing?	N/A			
N/A	Gutter Ponding?	N/A	N/A	Gutter Slope (%)	N/A
N/A	Gutter Lip Ht (in)	N/A	N/A	Gutter X Slope (%)	N/A
N/A	Painted X Walk1?	Yes	N/A	Painted X Walk2?	N/A
	X Walk 1 Direction	To SW		X Walk 2 Direction	N/A
N/A	X Walk 1 Width (in)	97.0	N/A	X Walk 2 Width (in)	N/A
	X Walk 1 Slope (%)	2.7		X Walk 2 Slope (%)	N/A
	X Walk 1 X Slope (%)	2.8		X Walk 2 X Slope (%)	N/A

N/A	Ramp inside XWalk1?	Yes	N/A	Ramp inside XWalk2?	N/A
	Road Slope (%)	N/A	N/A	Clear Space?	N/A
	Road X Slope (%)	N/A	N/A	Clear Space to XWalk (in)	N/A
N/A	Any Obstructions?	N/A	N/A	Storm Grate/Utility Hazard?	N/A
	Obstruction Type			Storm Grate/Utility Type	
		N/A			N/A
		Yes		Surface Condition? (G/P)	Good

Remove & Replace Entire Ramp.

Total Cost: \$ 1850.00
