# Access Compliance Report

## Public Rights-of-Way

### (Curb Ramps)

Intersection ID: 6490	Main Street: AMY_DR	Cross Street: PAMELA_LORRAINE_DR	Location: NW
ADA ID: 6867D22906DE	Ramp Type: Perp	Initial Pass/Fail: Pass	Overall Compliance: No
Severity Score: 30			
Codes/Mitigation Info/Possible Solution		Field Measurements/Component Compliance

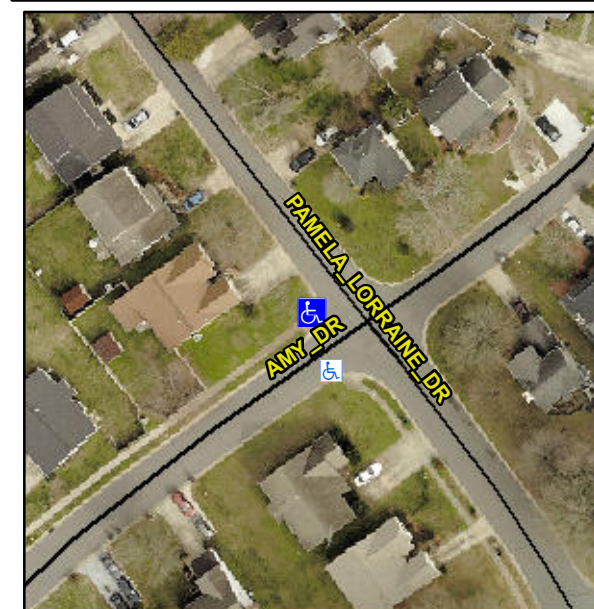
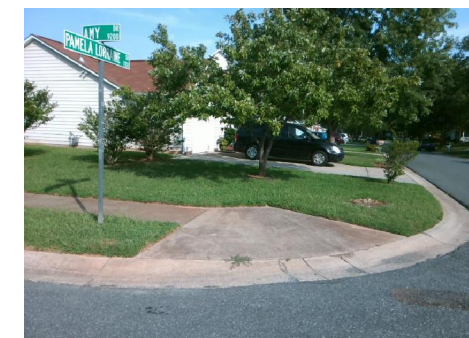
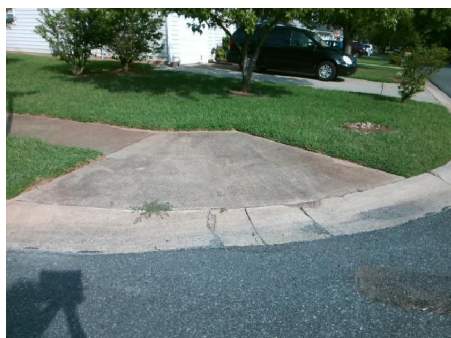
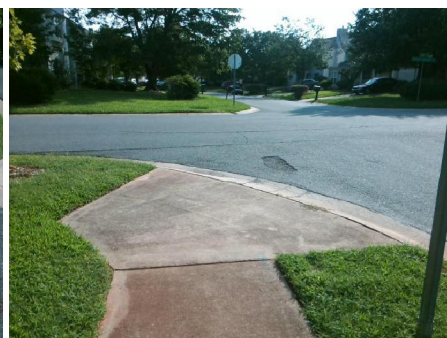
**Not Found, R304.2.2-Perp, R304.3.2-Para, R305, R302.7, R302.7.2, R304.5.4**

Compliance	Description	Data	Compliance	Description	Data
N/A	Ramp Length (in)	51.0	Yes	Ramp Slope (%)	5.1
Yes	Ramp Width (in)	72.0	Yes	Ramp XSlope (%)	1.0
N/A	Flare Type LT	Sloped	N/A	Flare Type RT	N/A
N/A	Flare Slope LT (%)	1.5	N/A	Flare Slope RT (%)	2.0
N/A	Flare Traversable LT?	No	N/A	Flare Traversable RT?	No
Yes	Landing Length (in)	48.0	No	DWS Provided?	No
Yes	Landing Width (in)	48.0	N/A	DWS Contrast?	No
No	Landing Slope (%)	3.9	N/A	DWS Length (in)	N/A
Yes	Landing X Slope (%)	2.0	N/A	DWS Full Width?	No
N/A	Landing Curb? (Y/N)	No	N/A	DWS Offset (in)	N/A
N/A	Shared Landing?	No			
No	Gutter Ponding?	Yes	No	Gutter Slope (%)	7.9
No	Gutter Lip Ht (in)	0.8	Yes	Gutter X Slope (%)	0.3
N/A	Painted X Walk1?	No	N/A	Painted X Walk2?	N/A
	X Walk 1 Direction	To S		X Walk 2 Direction	N/A
N/A	X Walk 1 Width (in)	N/A	N/A	X Walk 2 Width (in)	N/A
	X Walk 1 Slope (%)	3.3		X Walk 2 Slope (%)	N/A
	X Walk 1 X Slope (%)	1.9		X Walk 2 X Slope (%)	N/A

N/A	Ramp inside XWalk1?	N/A	N/A	Ramp inside XWalk2?	N/A
	Road Slope (%)	N/A	N/A	Clear Space?	Yes
	Road X Slope (%)	N/A	N/A	Clear Space to XWalk (in)	N/A
Yes	Any Obstructions?	No	Yes	Storm Grate/Utility Hazard?	No
	Obstruction Type			Storm Grate/Utility Type	
		N/A			N/A
			Yes	Surface Condition? (G/P)	Good

**Remove & Replace Entire Ramp.  
Remove & Replace Gutter.**

Total Cost: \$ 2600.00
