Access Compliance Report

Public Rights-of-Way

(Curb Ramps)

Intersection ID: 46529	Main Street: BEAVER_CREEK_DR	Cross Street: PROSPERITY_CHURCH_RD	Location: NE
ADA ID: 686DAE119180	Ramp Type: Perp	Initial Pass/Fail: Fail	Overall Compliance: No
Severity Score: 8.75			
Codes/Mitigation Info/Possible Solution		Field Measurements/Component Compliance

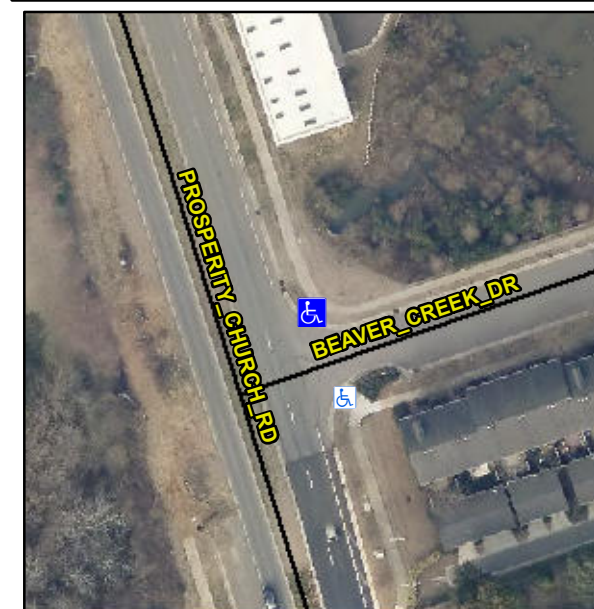
Compliance	Description	Data	Compliance	Description	Data
N/A	Ramp Length (in)	72.0	Yes	Ramp Slope (%)	7.2
No	Ramp Width (in)	40.0	Yes	Ramp XSlope (%)	1.2
N/A	Flare Type LT	N/A	N/A	Flare Type RT	N/A
N/A	Flare Slope LT (%)	N/A	N/A	Flare Slope RT (%)	N/A
N/A	Flare Traversable LT?	N/A	N/A	Flare Traversable RT?	N/A
N/A	Landing Length (in)	N/A	N/A	DWS Provided?	N/A
N/A	Landing Width (in)	N/A	N/A	DWS Contrast?	N/A
N/A	Landing Slope (%)	N/A	N/A	DWS Length (in)	N/A
N/A	Landing X Slope (%)	N/A	N/A	DWS Full Width?	N/A
N/A	Landing Curb? (Y/N)	N/A	N/A	DWS Offset (in)	N/A
N/A	Shared Landing?	N/A			
N/A	Gutter Ponding?	N/A	N/A	Gutter Slope (%)	N/A
N/A	Gutter Lip Ht (in)	N/A	N/A	Gutter X Slope (%)	N/A
N/A	Painted X Walk1?	No	N/A	Painted X Walk2?	N/A
	X Walk 1 Direction	To S		X Walk 2 Direction	N/A
N/A	X Walk 1 Width (in)	N/A	N/A	X Walk 2 Width (in)	N/A
	X Walk 1 Slope (%)	2.4		X Walk 2 Slope (%)	N/A
	X Walk 1 X Slope (%)	0.9		X Walk 2 X Slope (%)	N/A

N/A	Ramp inside XWalk1?	N/A	N/A	Ramp inside XWalk2?	N/A
	Road Slope (%)	N/A	N/A	Clear Space?	N/A
	Road X Slope (%)	N/A	N/A	Clear Space to XWalk (in)	N/A
N/A	Any Obstructions?	N/A	N/A	Storm Grate/Utility Hazard?	N/A
	Obstruction Type			Storm Grate/Utility Type	
		N/A			N/A
		Yes		Surface Condition? (G/P)	Good

Possible Solutions:

Remove & Replace Entire Ramp.
