Access Compliance Report

Public Rights-of-Way

(Curb Ramps)

Intersection ID: 29164	Main Street: GARRISON_RD	Cross Street: PURPLE_BLOOM_LN	Location: N
ADA ID: 68819A9E065B	Ramp Type: PerpDiag	Initial Pass/Fail: Fail	Overall Compliance: No
			Severity Score: 33.75

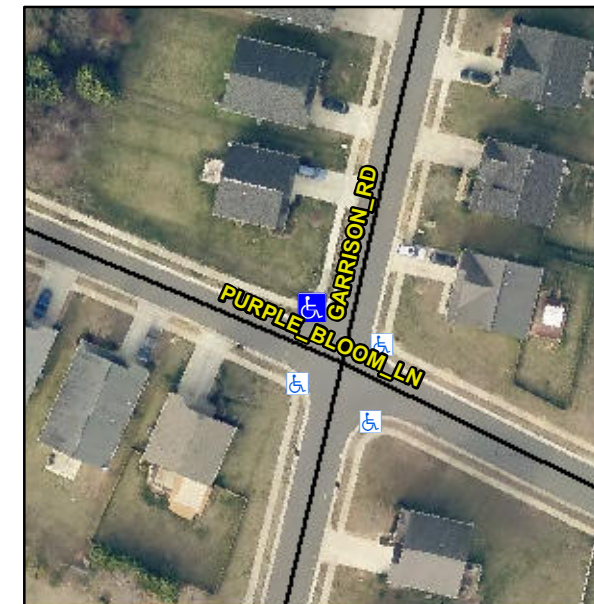
Not Found, R304.5.1, R304.5.3

Compliance	Description	Data	Compliance	Description	Data
N/A	Ramp Length (in)	49.0	Yes	Ramp Slope (%)	7.4
No	Ramp Width (in)	41.0	No	Ramp XSlope (%)	11.5
N/A	Flare Type LT	N/A	N/A	Flare Type RT	N/A
N/A	Flare Slope LT (%)	N/A	N/A	Flare Slope RT (%)	N/A
N/A	Flare Traversable LT?	N/A	N/A	Flare Traversable RT?	N/A
N/A	Landing Length (in)	N/A	N/A	DWS Provided?	N/A
N/A	Landing Width (in)	N/A	N/A	DWS Contrast?	N/A
N/A	Landing Slope (%)	N/A	N/A	DWS Length (in)	N/A
N/A	Landing X Slope (%)	N/A	N/A	DWS Full Width?	N/A
N/A	Landing Curb? (Y/N)	N/A	N/A	DWS Offset (in)	N/A
N/A	Shared Landing?	N/A			
N/A	Gutter Ponding?	N/A	N/A	Gutter Slope (%)	N/A
N/A	Gutter Lip Ht (in)	N/A	N/A	Gutter X Slope (%)	N/A
N/A	Painted X Walk1?	No	N/A	Painted X Walk2?	No
	X Walk 1 Direction	To SW		X Walk 2 Direction	To SE
N/A	X Walk 1 Width (in)	N/A	N/A	X Walk 2 Width (in)	N/A
	X Walk 1 Slope (%)	7.1		X Walk 2 Slope (%)	1.0
	X Walk 1 X Slope (%)	1.3		X Walk 2 X Slope (%)	7.5

N/A	Ramp inside XWalk1?	N/A	N/A	Ramp inside XWalk2?	N/A
	Road Slope (%)	6.6	N/A	Clear Space?	N/A
	Road X Slope (%)	3.2	N/A	Clear Space to XWalk (in)	N/A
N/A	Any Obstructions?	N/A	N/A	Storm Grate/Utility Hazard?	N/A
	Obstruction Type			Storm Grate/Utility Type	
		N/A			N/A
			Yes	Surface Condition? (G/P)	Good

Remove & Replace Curb Ramp With Two New Directional Ramps or Equivalent.
